Geotechnical Completion Report

Millwater Subdivision - Arrans Hill
Precinct 5 - Stage 2

Prepared for
WFH Properties Ltd
Prepared by
Tonkin & Taylor Ltd

Date
September 2020

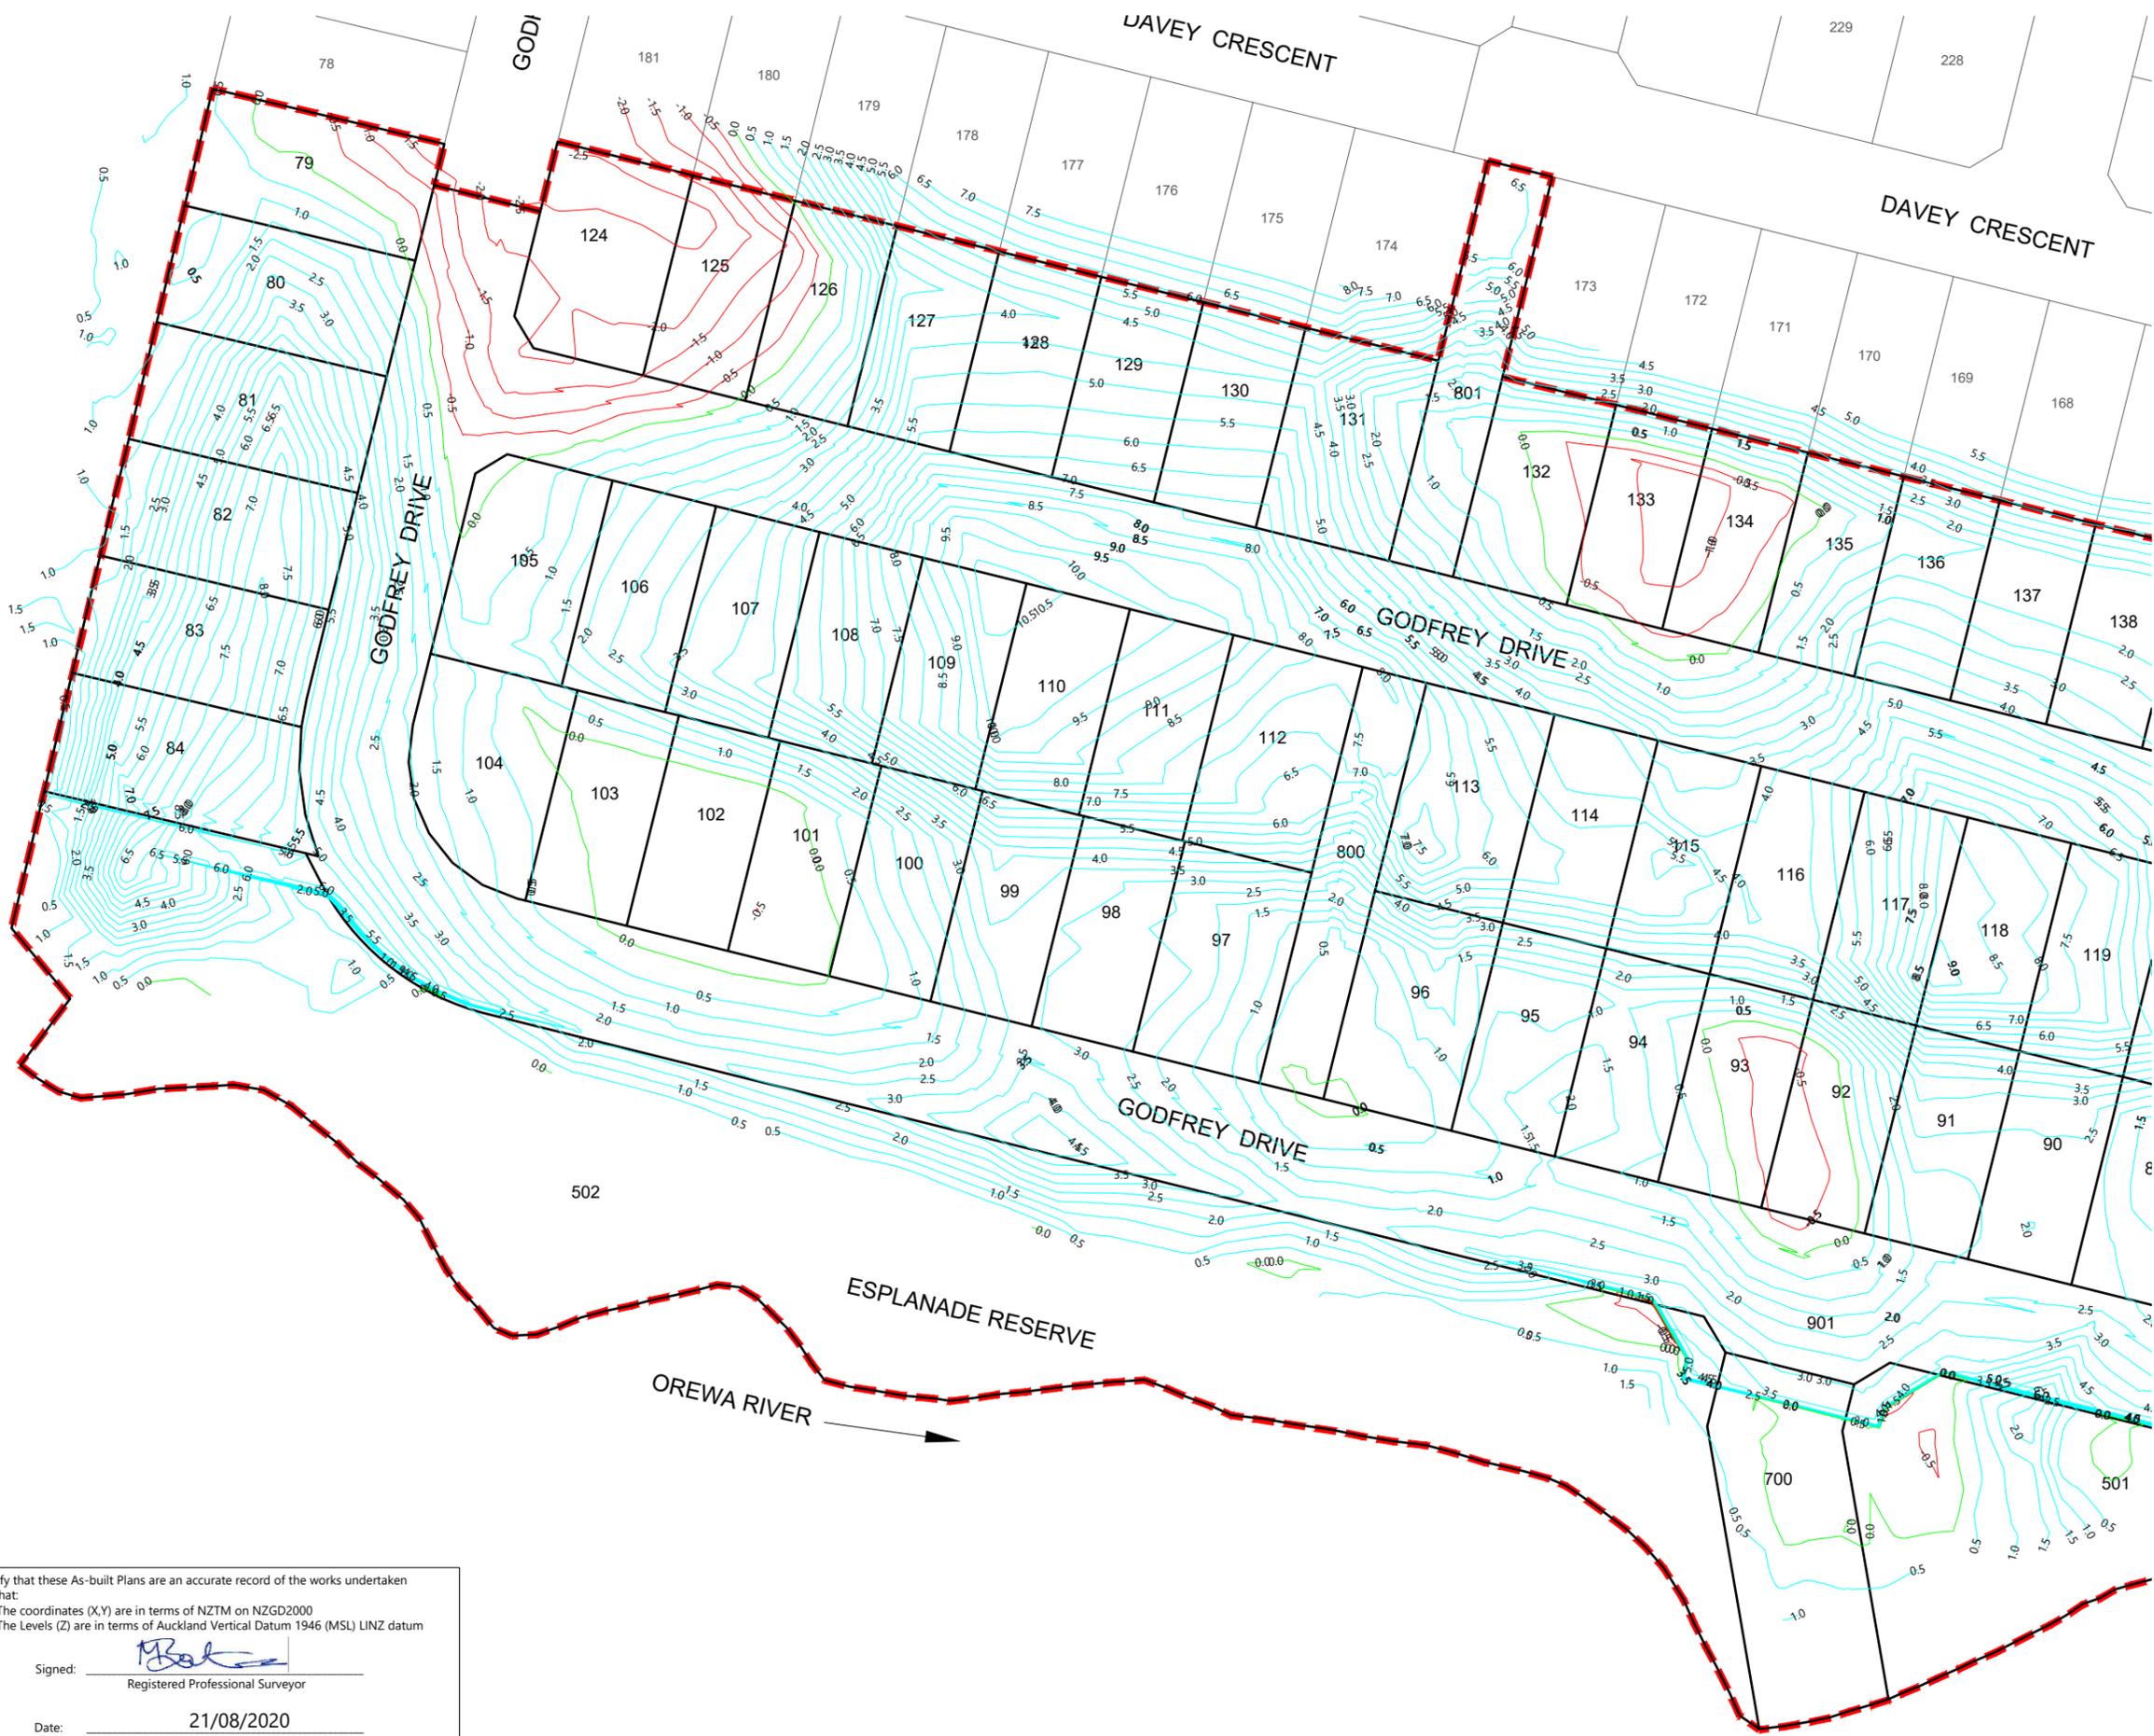
**ARRAN HILL PRECINCT 5
 STAGE 2
 CUT & FILL AS-BUILT
 ORIGINAL TO FINAL SURFACE
 SHEET 1 OF 2**

STATUS	AS-BUILT	REV
SCALE	1:1000 @ A3	2
COUNCIL	AUCKLAND COUNCIL	
DWG NO	37502-02-114-AB

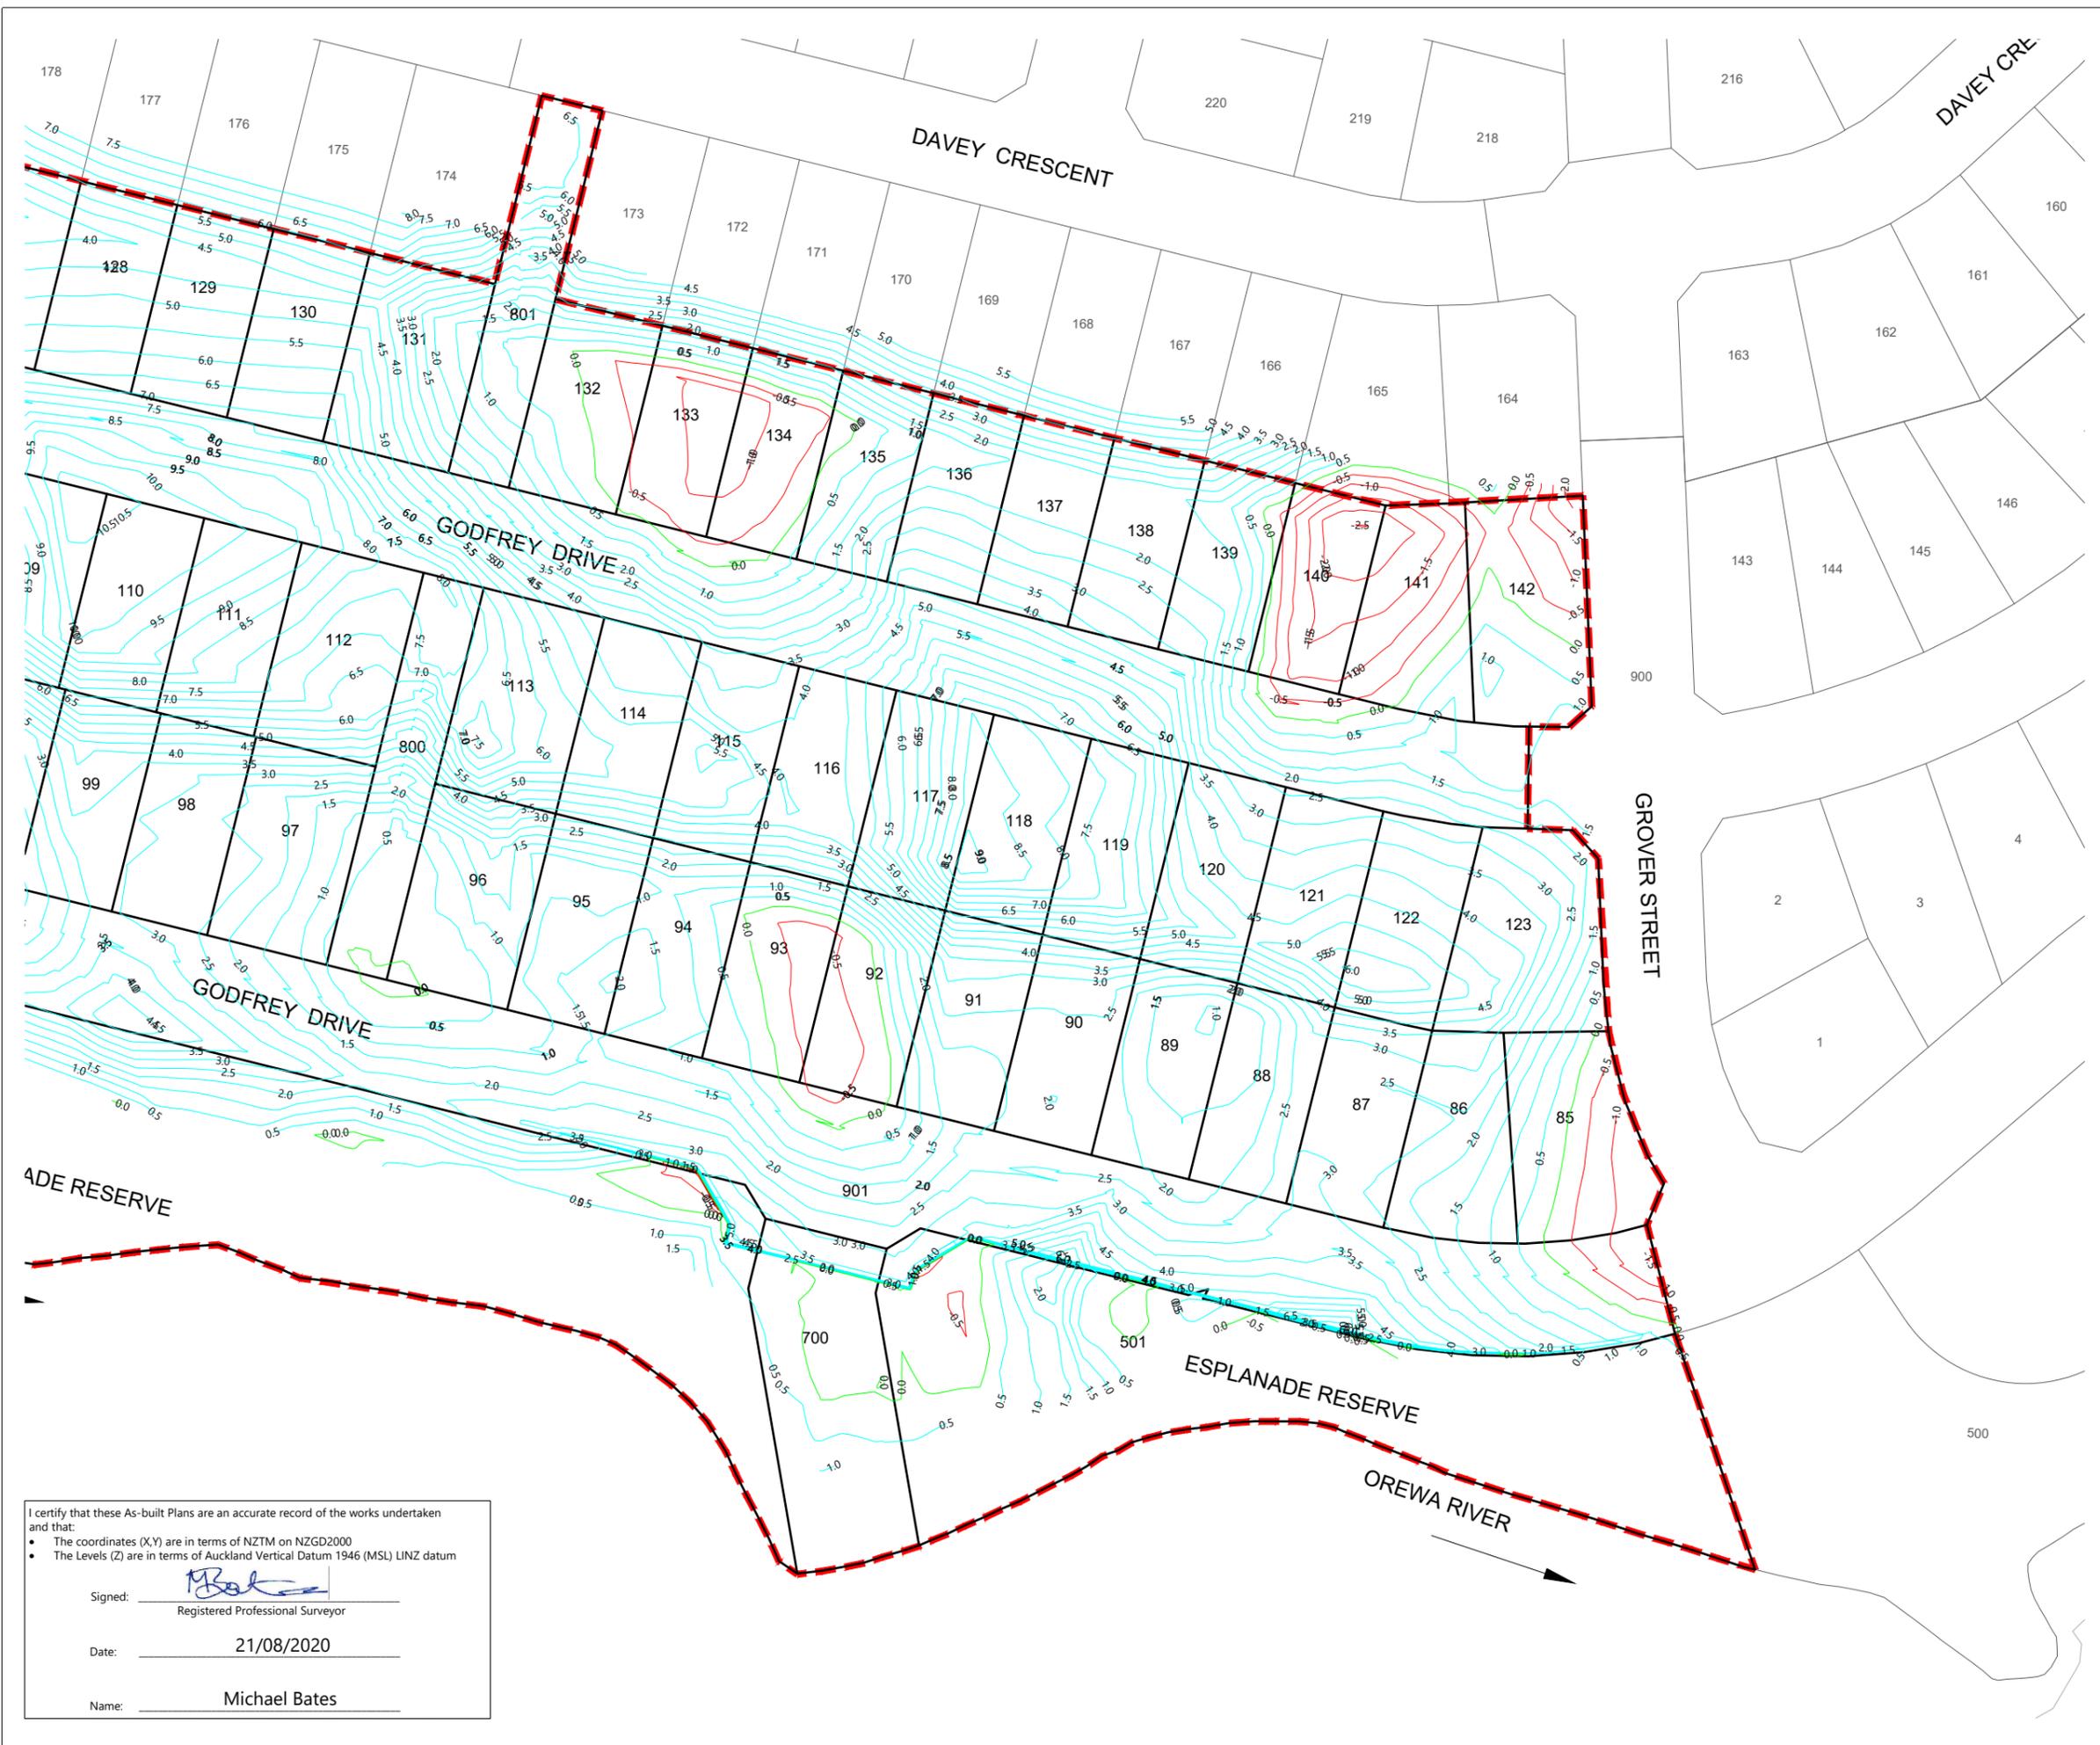
**ARRAN HILL PRECINCT 5
 STAGE 2**
**CUT & FILL AS-BUILT
 ORIGINAL TO FINAL SURFACE
 SHEET 2 OF 2**

STATUS	AS-BUILT	REV
SCALE	1:1000 @ A3	2
COUNCIL	AUCKLAND COUNCIL	
DWG NO	37502-02-115-AB

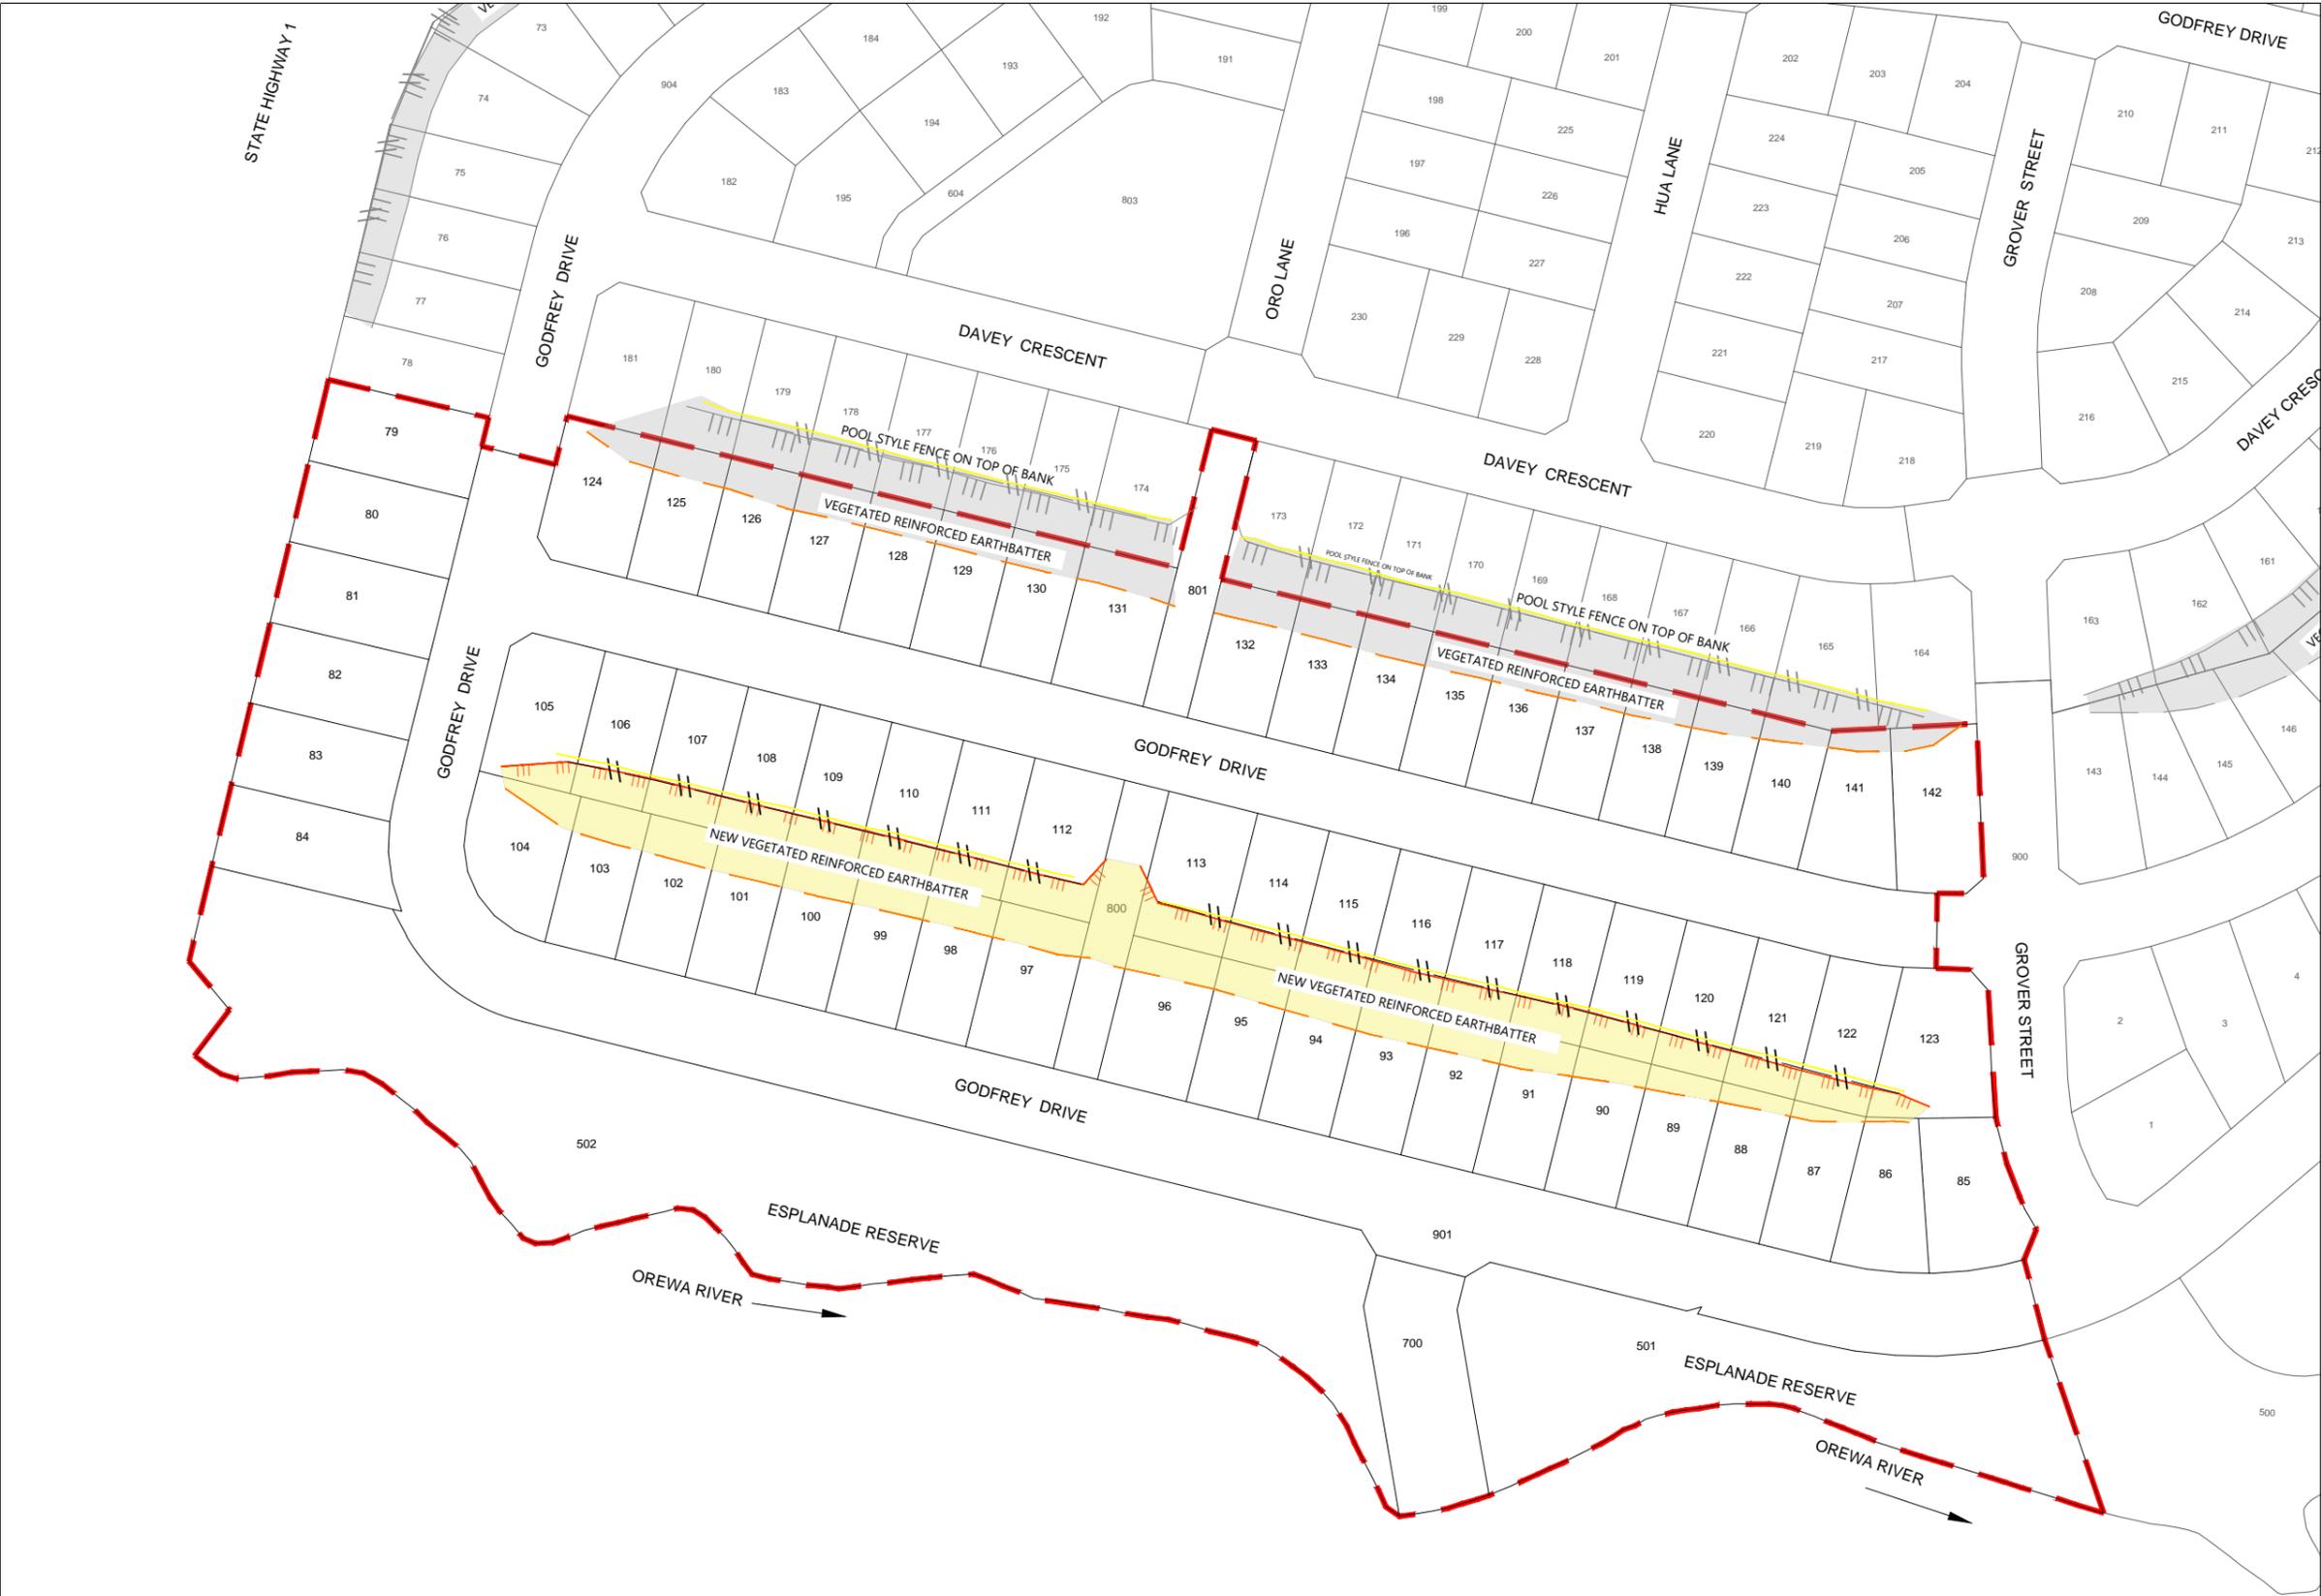
**REINFORCED EARTH BATTER &
SLOPE STABILISATION PLAN**

STATUS	ASBUILT	REV
SCALE	1:1500 @ A3	2
COUNCIL	AUCKLAND COUNCIL	
DWG NO	37502-02-140-AB

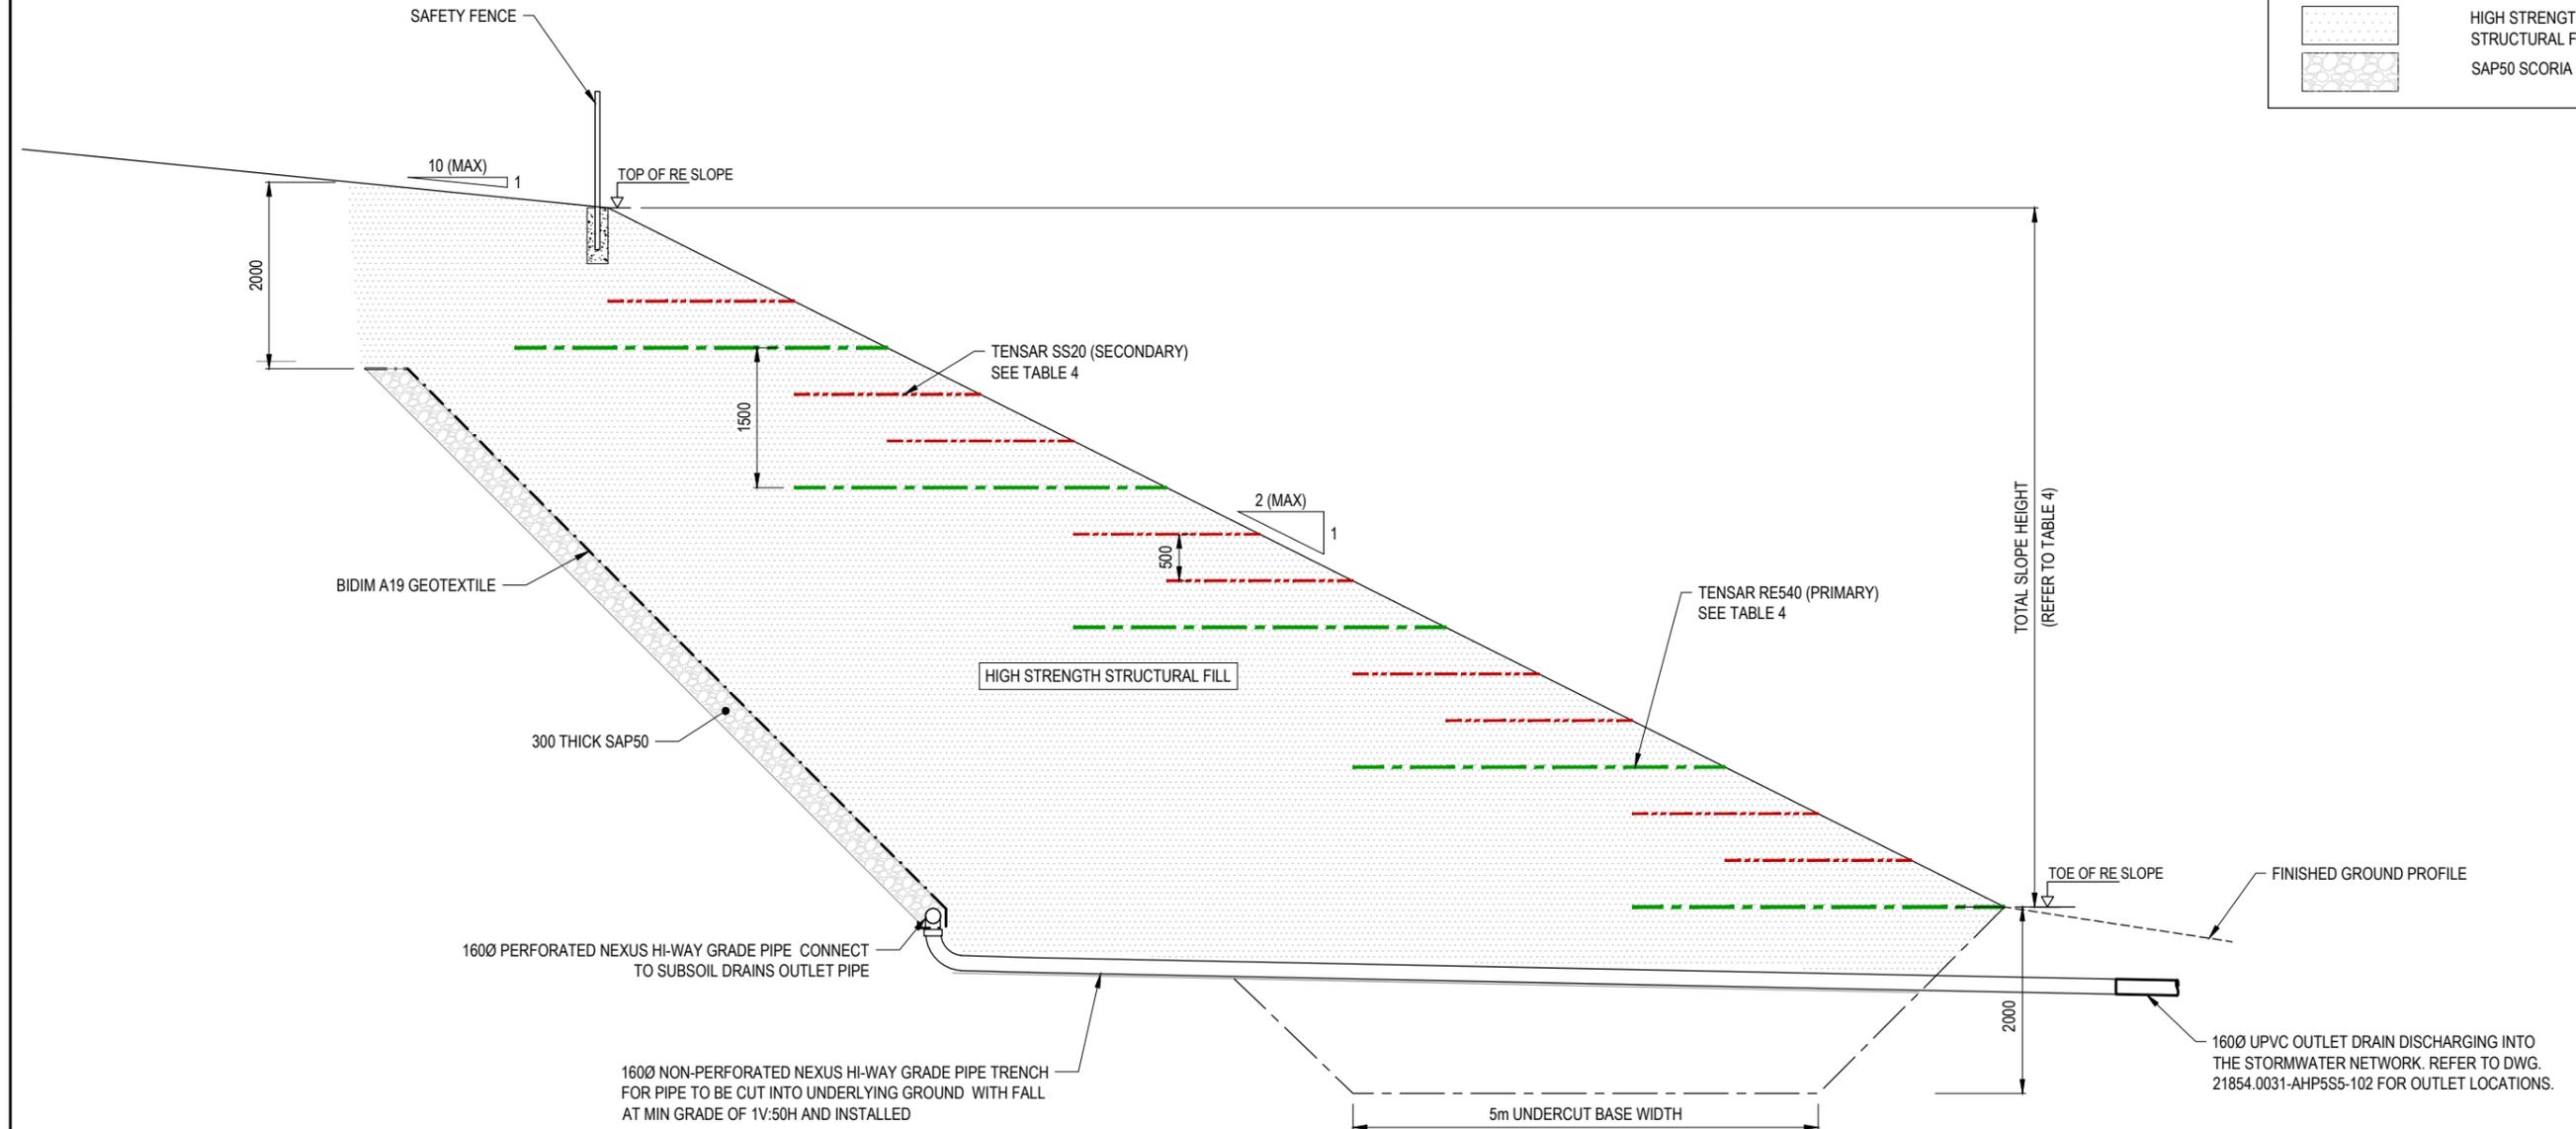
SECTION 17 RE SLOPE 4 AND 5
SCALE 1:75

Undercuts 1 and 3 were completed along the base of Reinforced Earth Slopes 4 and 5 to ensure competent foundation material for the reinforced earth slopes.

The foundations of Reinforced Earth Slopes 4 and 5 are composed of engineered fill material from an undercut. The foundations of Reinforced Earth Slopes 2, 3 and 9 are composed of engineered fill material from Shear Keys 1 and 2. The undercut and shear keys are described further in Sections 3.2 and 3.3, and presented on T+T Drawing 21854.0031-124 to 126 in Appendix B.

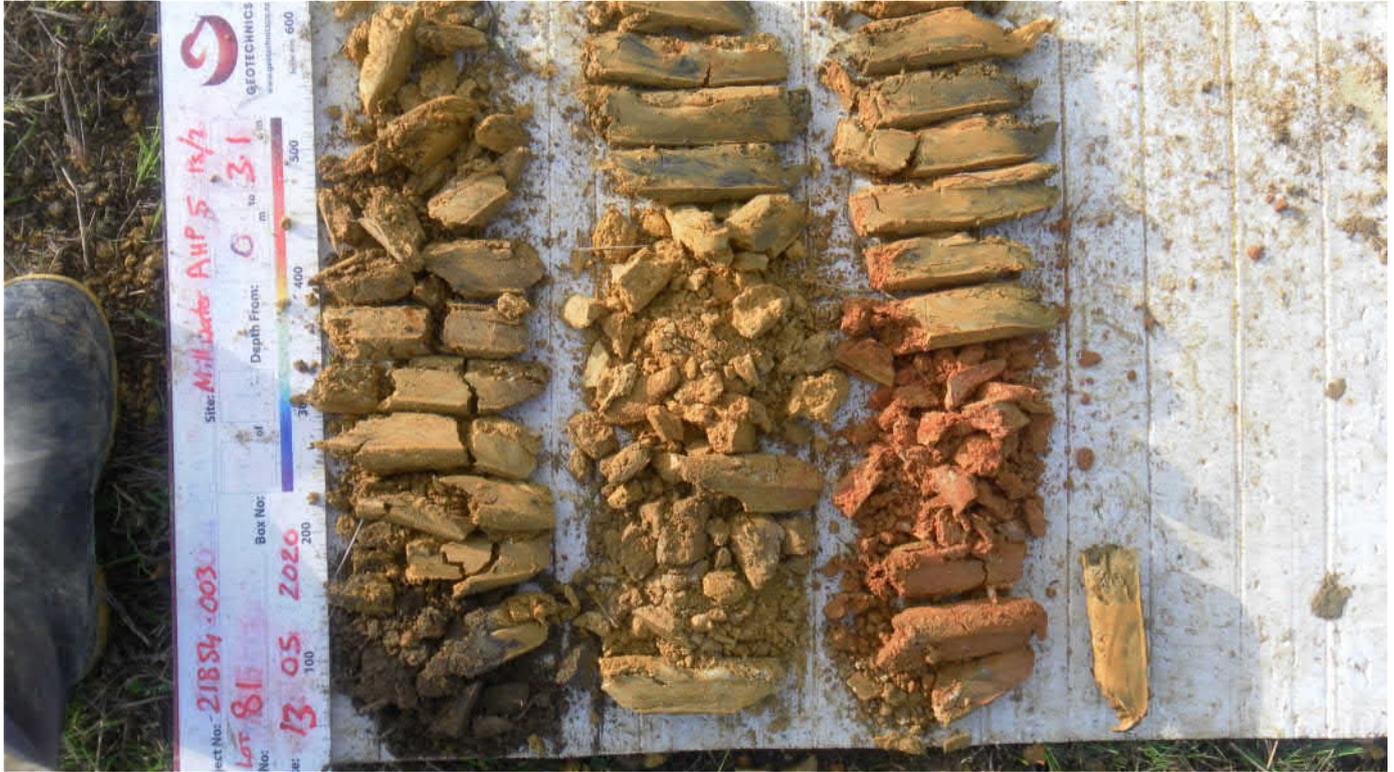
0.00-3.10m

PROJECT: Millwater P5 stg2		LOCATION: Orewa West	JOB No.: 21854.0031
CO-ORDINATES: (NZTM2000)	5949259.97 mN 1748907.69 mE	DRILL TYPE: 50mm hand auger	HOLE STARTED: 13/05/2020
R.L.:	26.59m	DRILL METHOD: HA	HOLE FINISHED: 13/05/2020
DATUM:	NZVD2016		DRILLED BY: GEOTECHNICS
			LOGGED BY: RBE CHECKED: WIRO

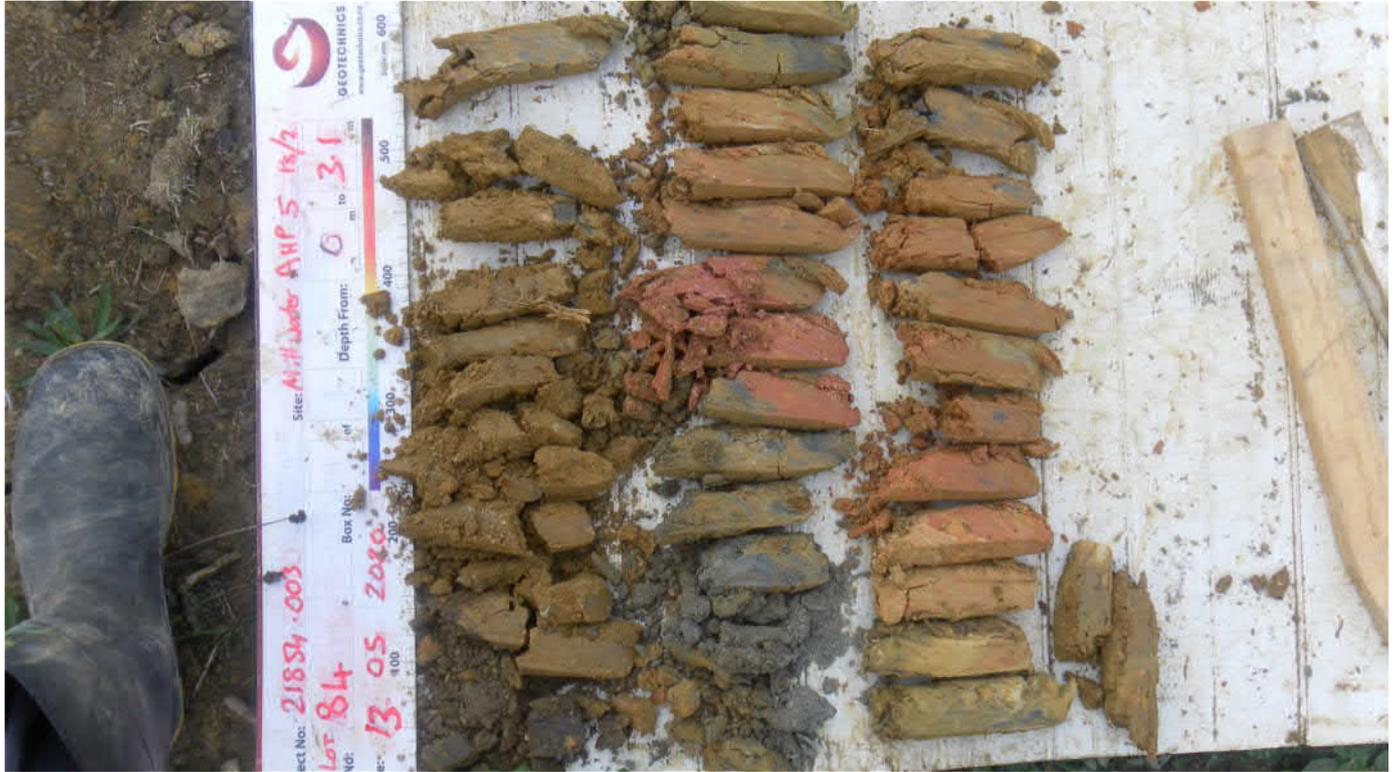
0.00-3.10m

PROJECT: Millwater P5 stg2		LOCATION: Orewa West	JOB No.: 21854.0031
CO-ORDINATES: (NZTM2000)	5949206.93 mN 1748897.21 mE	DRILL TYPE: 50mm hand auger	HOLE STARTED: 13/05/2020
R.L.:	20.20m	DRILL METHOD: HA	HOLE FINISHED: 13/05/2020
DATUM:	NZVD2016		DRILLED BY: GEOTECHNICS
			LOGGED BY: RBE CHECKED: WIRO

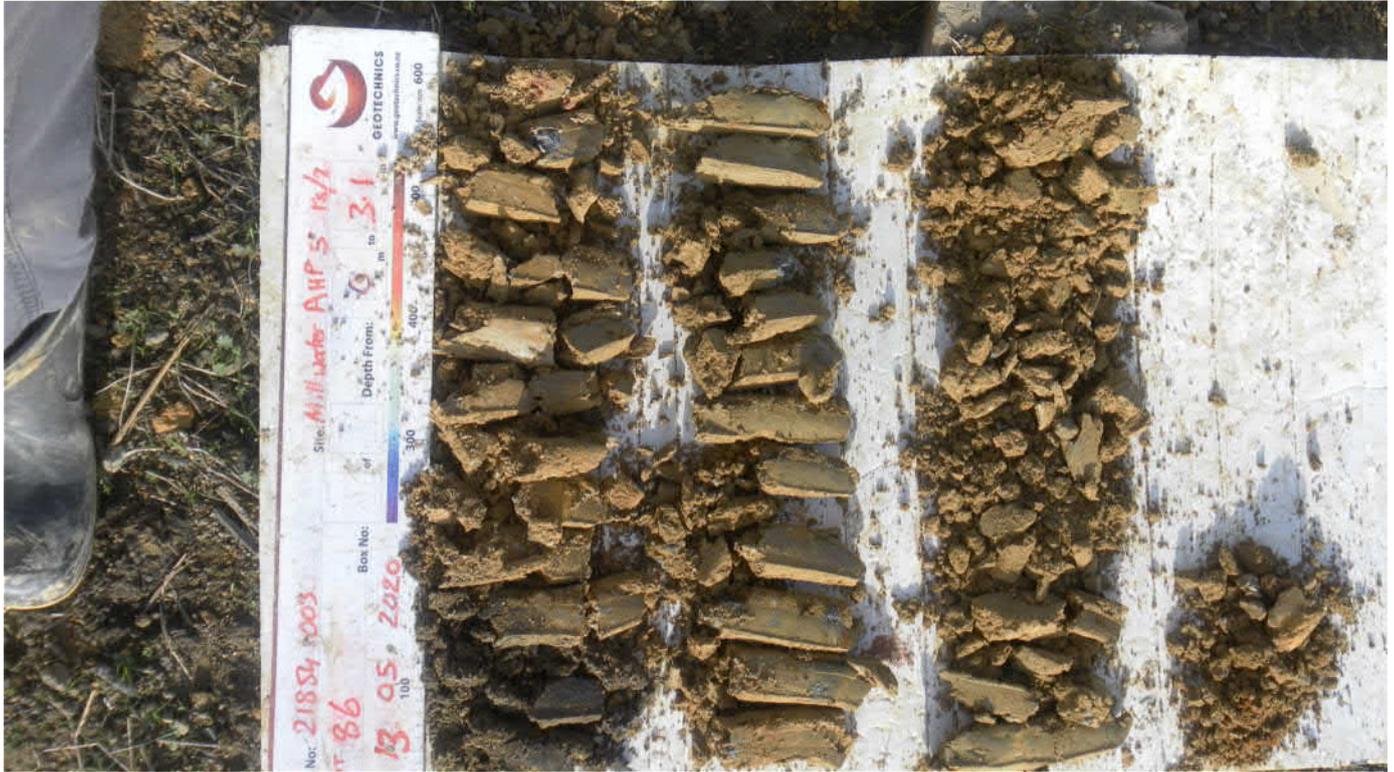
0.00-3.10m

PROJECT: Millwater P5 stg2		LOCATION: Orewa West	JOB No.: 21854.0031
CO-ORDINATES: (NZTM2000)	5949125.60 mN 1749231.14 mE	DRILL TYPE: 50mm hand auger	HOLE STARTED: 13/05/2020
R.L.:	15.19m	DRILL METHOD: HA	HOLE FINISHED: 13/05/2020
DATUM:	NZVD2016		DRILLED BY: GEOTECHNICS
			LOGGED BY: RBE CHECKED: WIRO

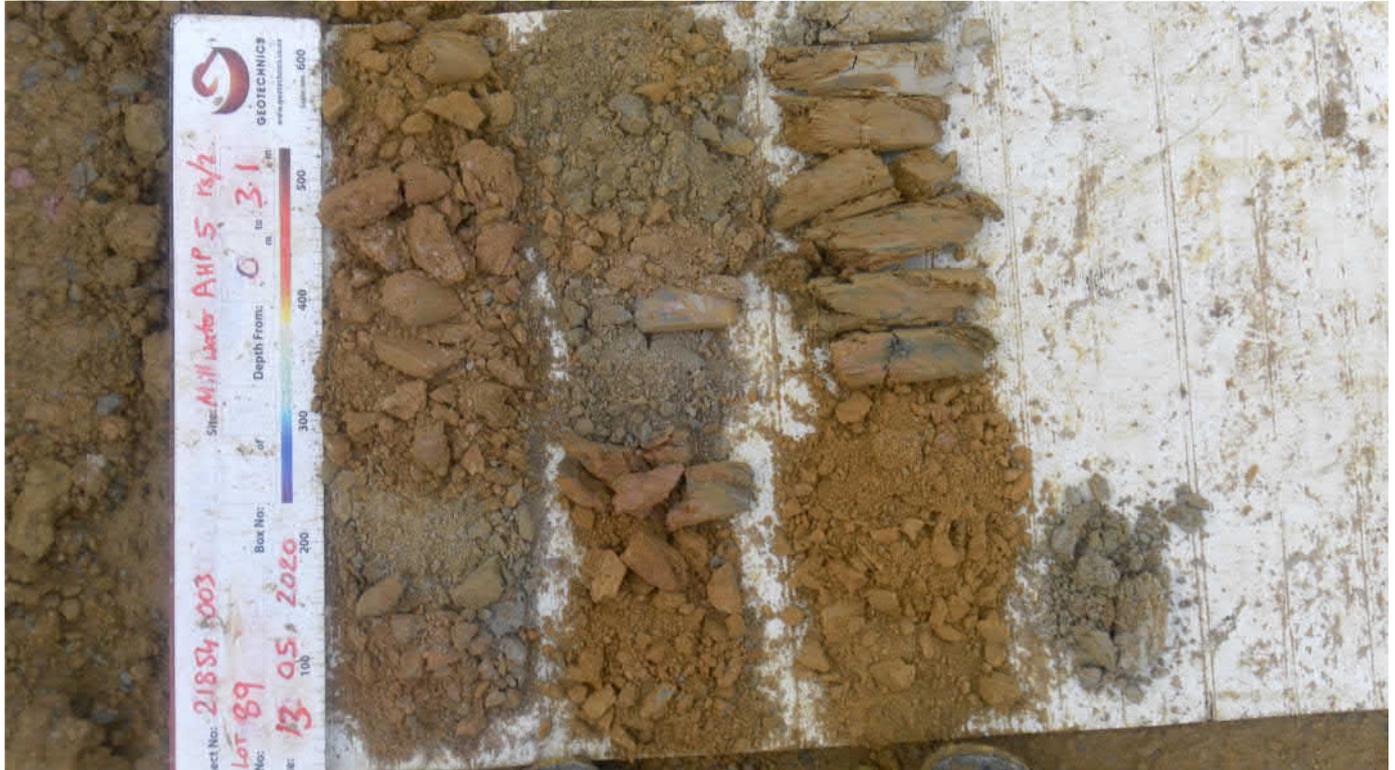
0.00-3.10m

PROJECT: Millwater P5 stg2		LOCATION: Orewa West	JOB No.: 21854.0031
CO-ORDINATES: (NZTM2000)	5949132.04 mN 1749189.17 mE	DRILL TYPE: 50mm hand auger	HOLE STARTED: 13/05/2020
R.L.:	15.83m	DRILL METHOD: HA	HOLE FINISHED: 13/05/2020
DATUM:	NZVD2016		DRILLED BY: GEOTECHNICS
			LOGGED BY: RBE CHECKED: WIRO

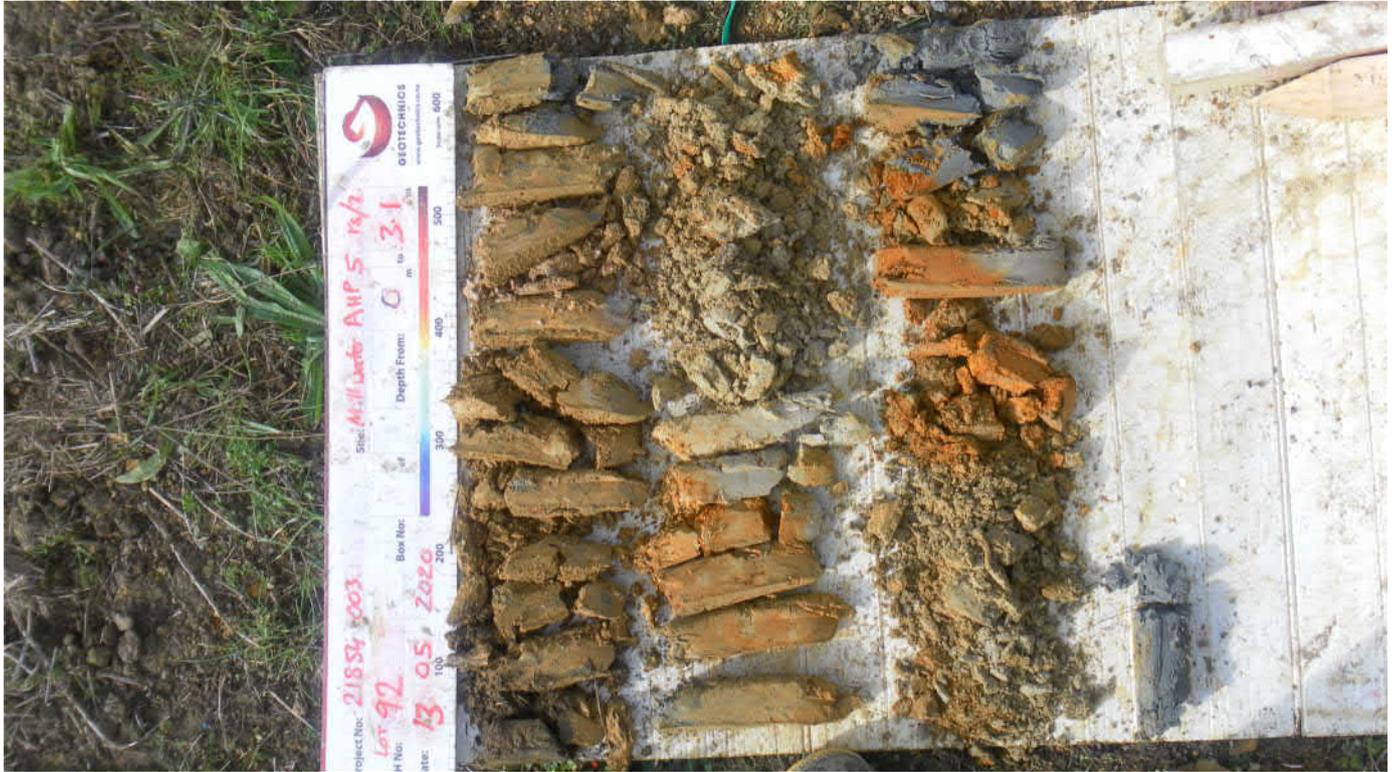
0.00-3.10m

PROJECT: Millwater P5 stg2		LOCATION: Orewa West	JOB No.: 21854.0031
CO-ORDINATES: (NZTM2000)	5949146.91 mN 1749137.78 mE	DRILL TYPE: 50mm hand auger	HOLE STARTED: 13/05/2020
R.L.:	17.20m	DRILL METHOD: HA	HOLE FINISHED: 13/05/2020
DATUM:	NZVD2016		DRILLED BY: GEOTECHNICS
			LOGGED BY: RBE CHECKED: WIRO

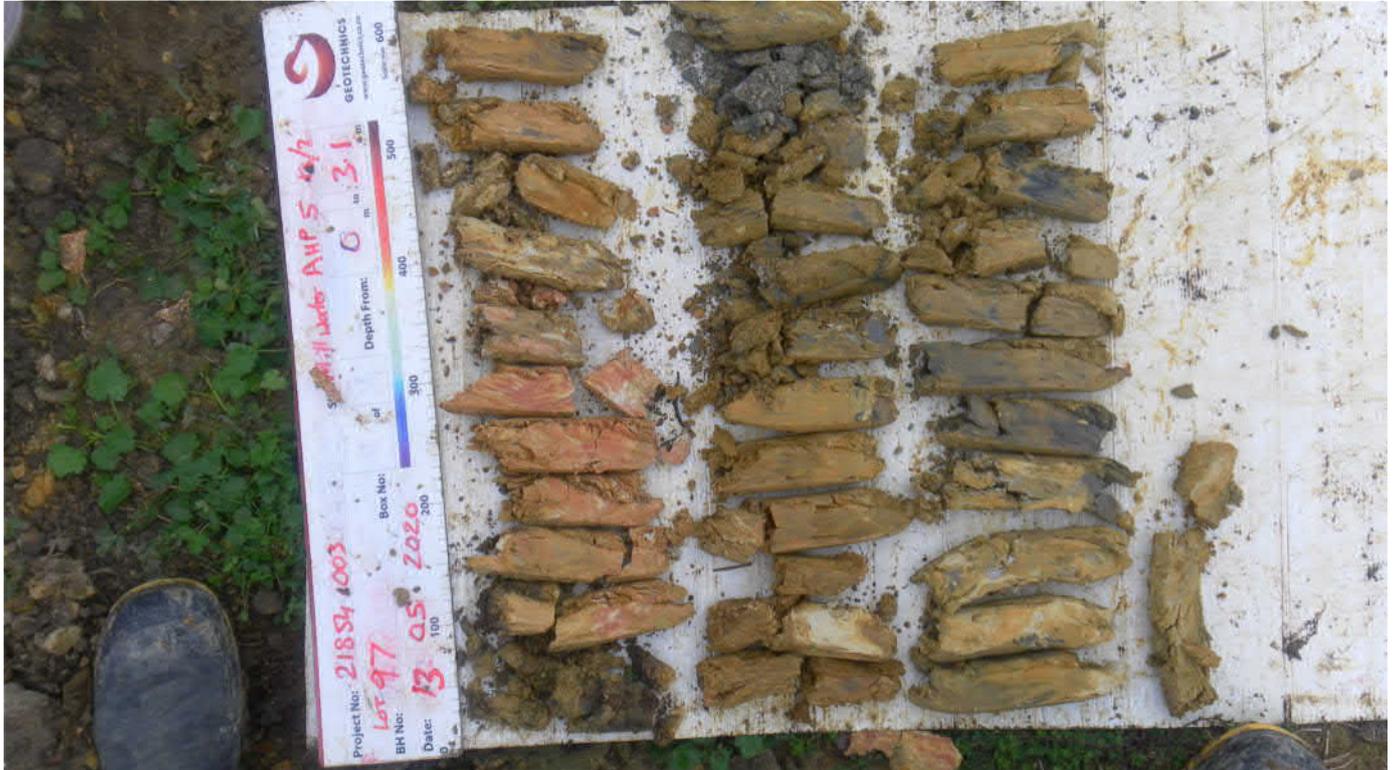
0.00-3.10m

PROJECT: Millwater P5 stg2		LOCATION: Orewa West	JOB No.: 21854.0031
CO-ORDINATES: (NZTM2000)	5949170.61 mN 1749042.52 mE	DRILL TYPE: 50mm hand auger	HOLE STARTED: 13/05/2020
R.L.:	18.31m	DRILL METHOD: HA	HOLE FINISHED: 13/05/2020
DATUM:	NZVD2016		DRILLED BY: GEOTECHNICS
			LOGGED BY: RBE CHECKED: WIRO

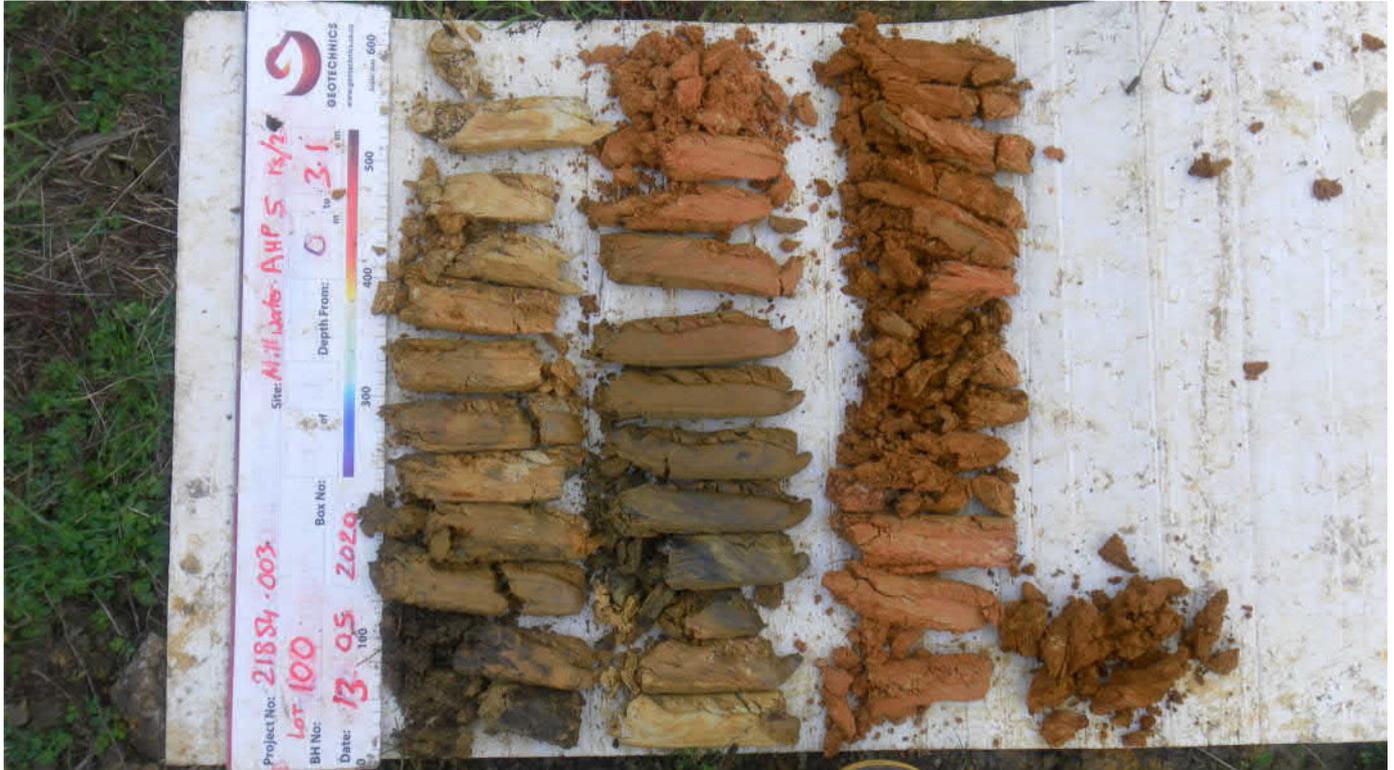
0.00-3.10m

PROJECT: Millwater P5 stg2		LOCATION: Orewa West	JOB No.: 21854.0031
CO-ORDINATES: (NZTM2000)	5949182.52 mN 1748997.33 mE	DRILL TYPE: 50mm hand auger	HOLE STARTED: 13/05/2020
R.L.:	18.88m	DRILL METHOD: HA	HOLE FINISHED: 13/05/2020
DATUM:	NZVD2016		DRILLED BY: GEOTECHNICS
			LOGGED BY: RBE CHECKED: WIRO
