Geotechnical Completion Report

Millwater Subdivision - Arrans Hill
Precinct 5 - Stage 2

Prepared for
WFH Properties Ltd
Prepared by
Tonkin & Taylor Ltd

Date
September 2020

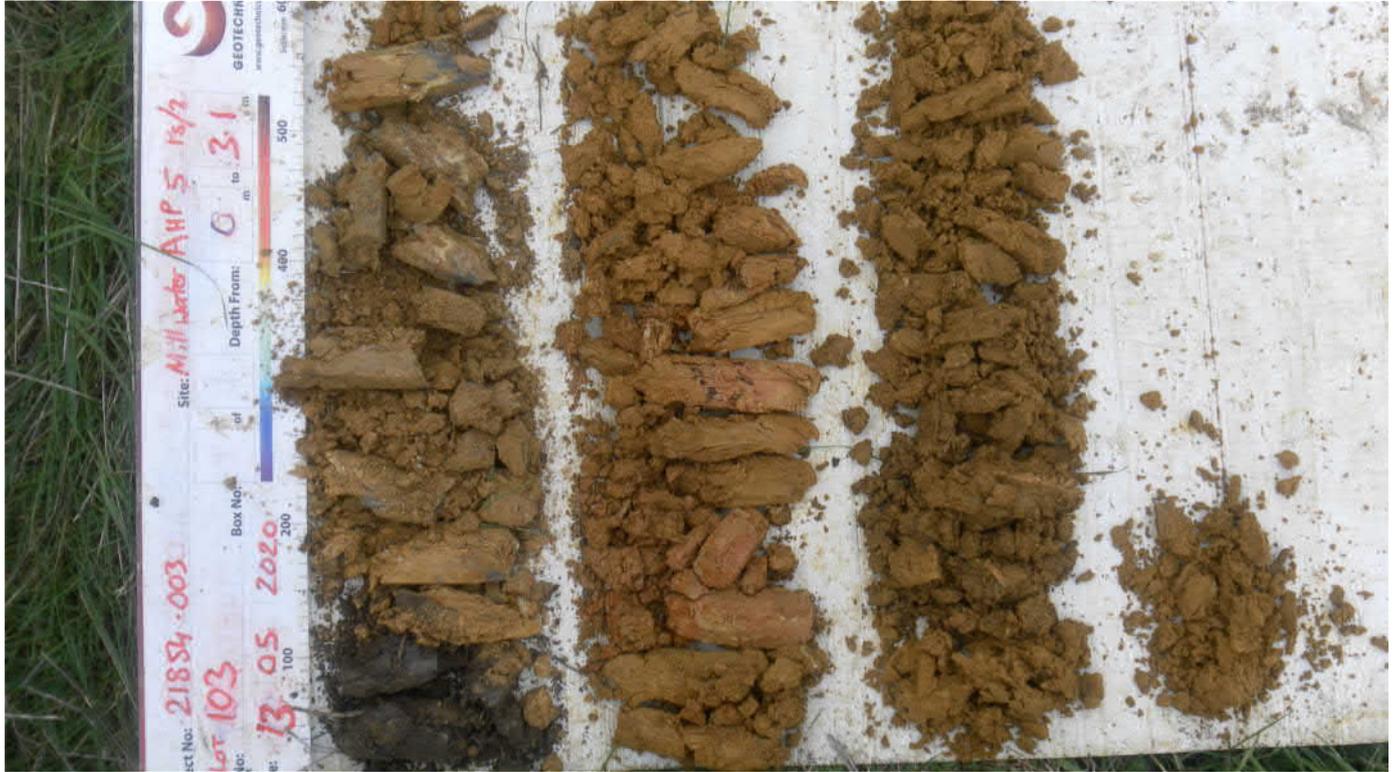
0.00-3.10m

PROJECT: Millwater P5 stg2		LOCATION: Orewa West	JOB No.: 21854.0031
CO-ORDINATES: (NZTM2000)	5949195.58 mN 1748950.02 mE	DRILL TYPE: 50mm hand auger	HOLE STARTED: 13/05/2020
R.L.:	19.56m	DRILL METHOD: HA	HOLE FINISHED: 13/05/2020
DATUM:	NZVD2016		DRILLED BY: GEOTECHNICS
			LOGGED BY: RBE CHECKED: WIRO

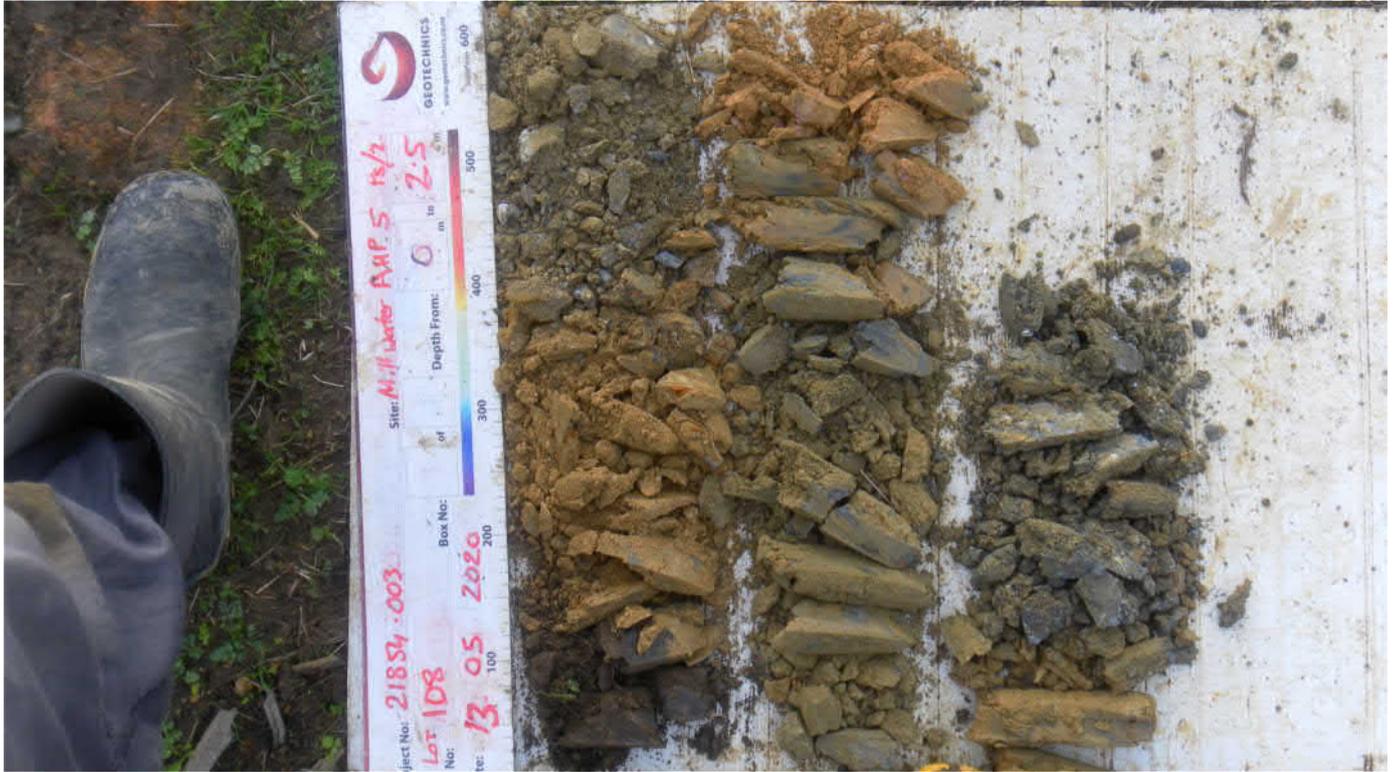
0.00-2.50m

PROJECT: Millwater P5 stg2		LOCATION: Orewa West	JOB No.: 21854.0031
CO-ORDINATES: (NZTM2000)	5949234.82 mN 1748991.80 mE	DRILL TYPE: 50mm hand auger	HOLE STARTED: 13/05/2020
R.L.:	30.96m	DRILL METHOD: HA	HOLE FINISHED: 13/05/2020
DATUM:	NZVD2016		DRILLED BY: GEOTECHNICS
			LOGGED BY: RBE CHECKED: WIRO

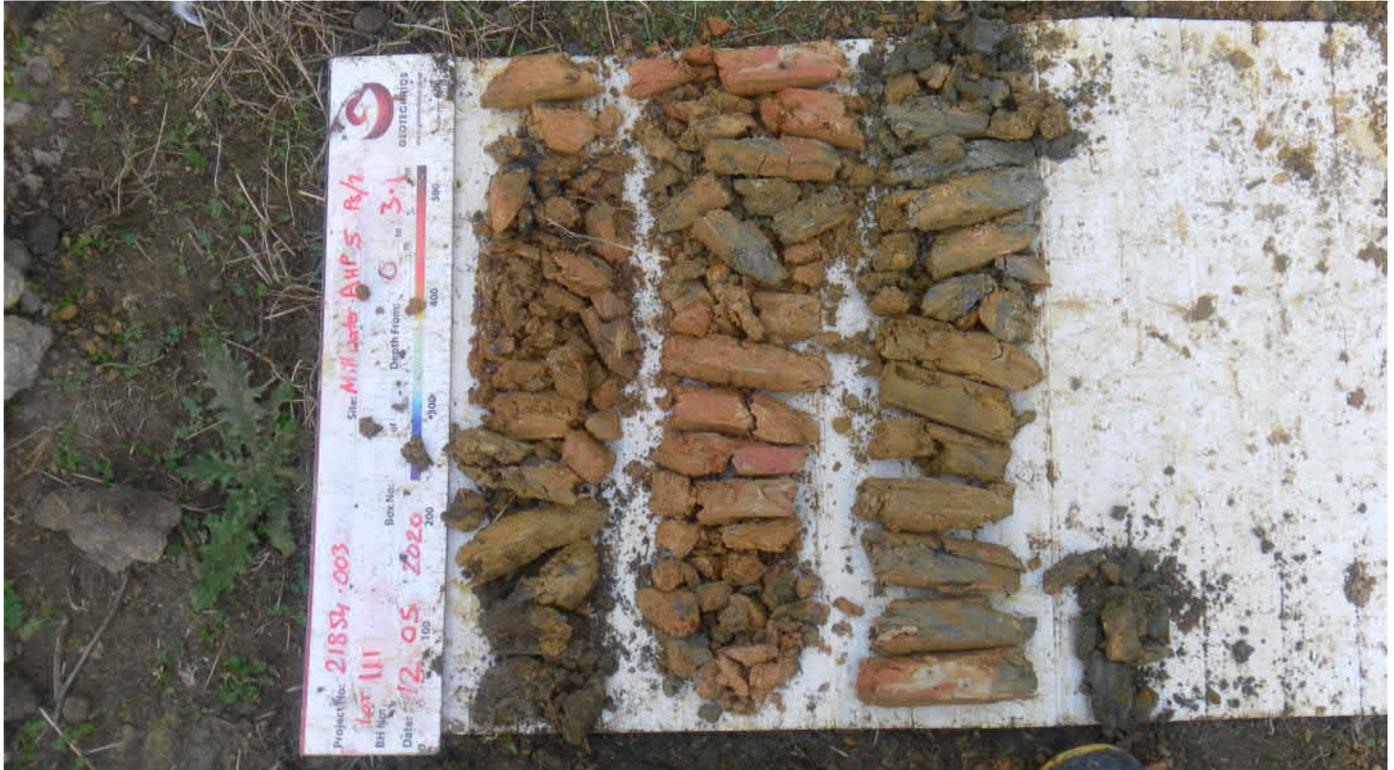
0.00-3.10m

PROJECT: Millwater P5 stg2		LOCATION: Orewa West	JOB No.: 21854.0031
CO-ORDINATES: (NZTM2000)	5949223.08 mN 1749036.98 mE	DRILL TYPE: 50mm hand auger	HOLE STARTED: 12/05/2020
R.L.:	30.91m	DRILL METHOD: HA	HOLE FINISHED: 12/05/2020
DATUM:	NZVD2016		DRILLED BY: GEOTECHNICS
			LOGGED BY: RBE CHECKED: WIRO

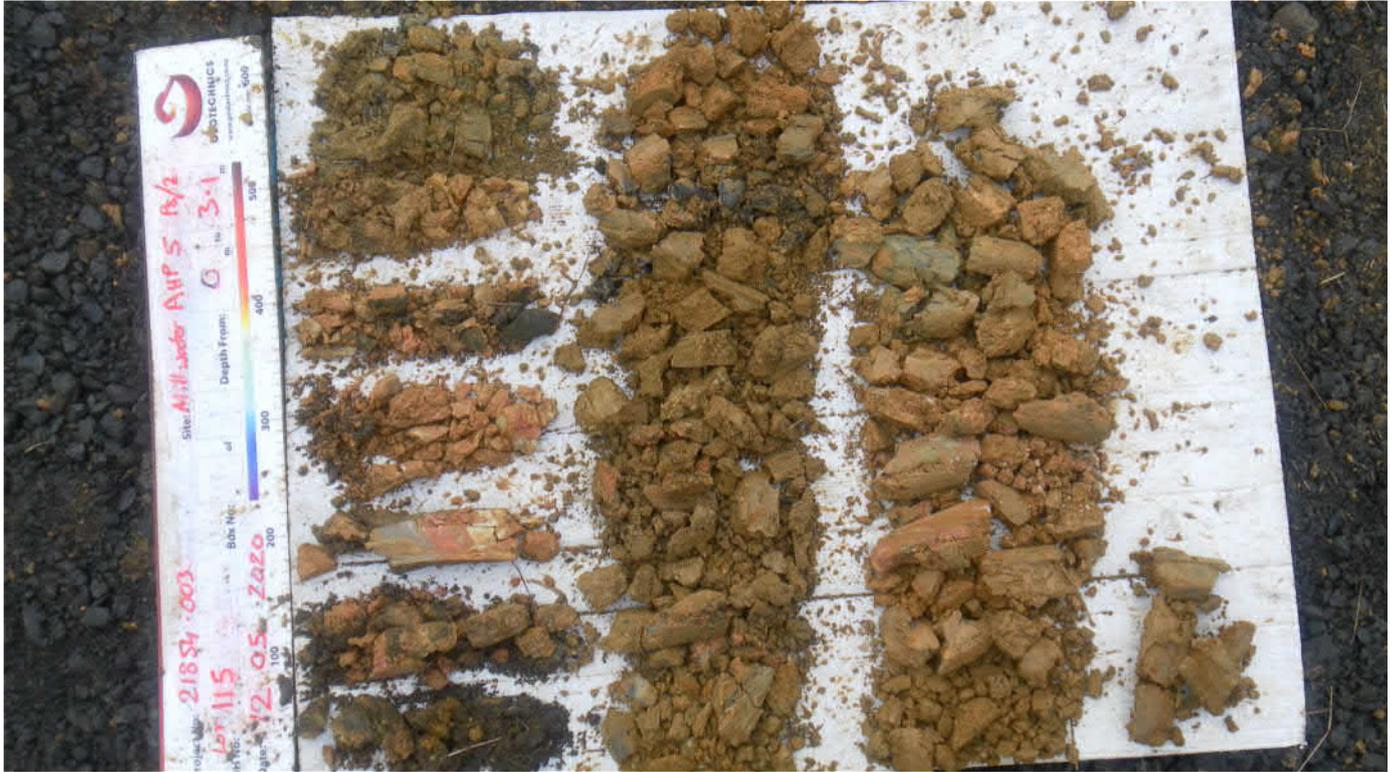
0.00-3.10m

PROJECT: Millwater P5 stg2		LOCATION: Orewa West	JOB No.: 21854.0031
CO-ORDINATES: (NZTM2000)	5949201.91 mN 1749119.48 mE	DRILL TYPE: 50mm hand auger	HOLE STARTED: 12/05/2020
R.L.:	30.33m	DRILL METHOD: HA	HOLE FINISHED: 12/05/2020
DATUM:	NZVD2016		DRILLED BY: GEOTECHNICS
			LOGGED BY: RBE CHECKED: WIRO

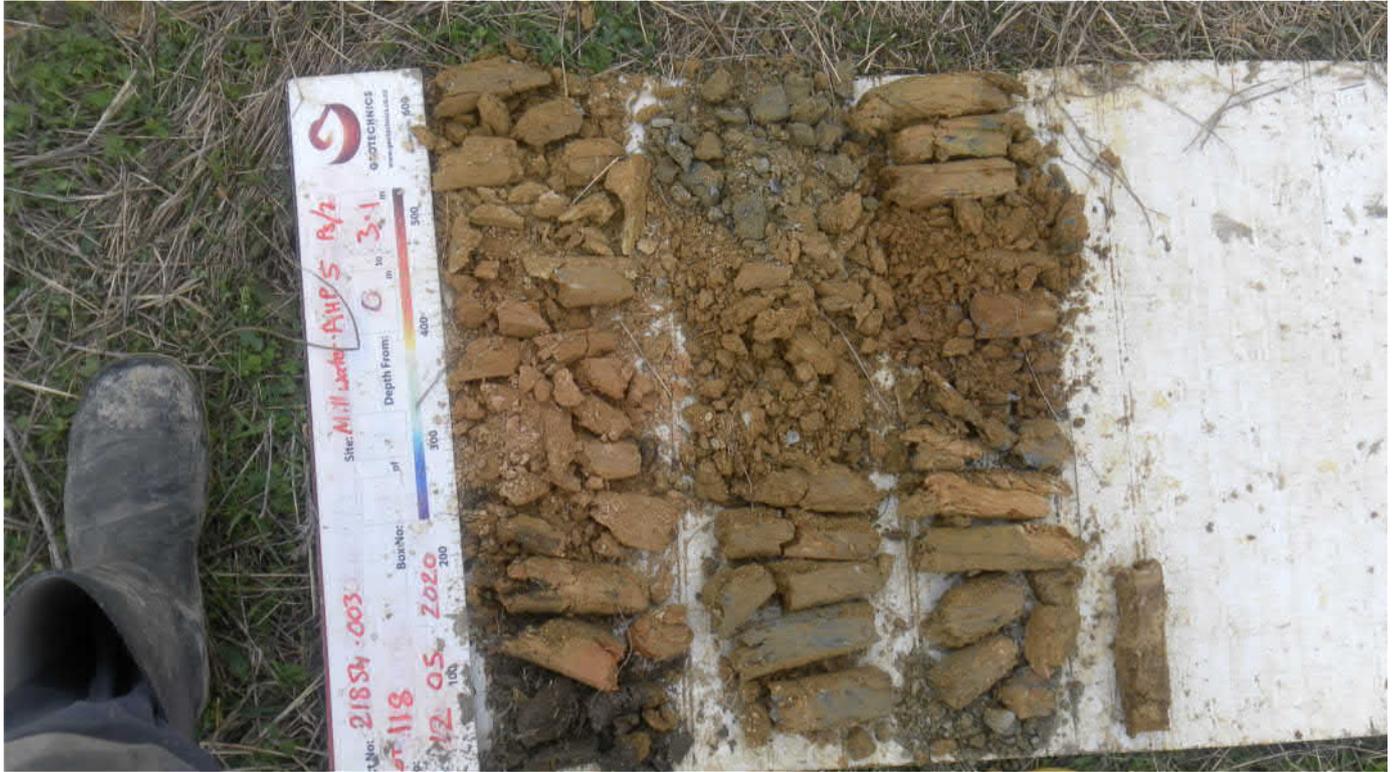
0.00-3.10m

PROJECT: Millwater P5 stg2		LOCATION: Orewa West	JOB No.: 21854.0031
CO-ORDINATES: (NZTM2000)	5949190.33 mN 1749165.85 mE	DRILL TYPE: 50mm hand auger	HOLE STARTED: 12/05/2020
R.L.:	28.35m	DRILL METHOD: HA	HOLE FINISHED: 12/05/2020
DATUM:	NZVD2016		DRILLED BY: GEOTECHNICS
			LOGGED BY: RBE CHECKED: WIRO

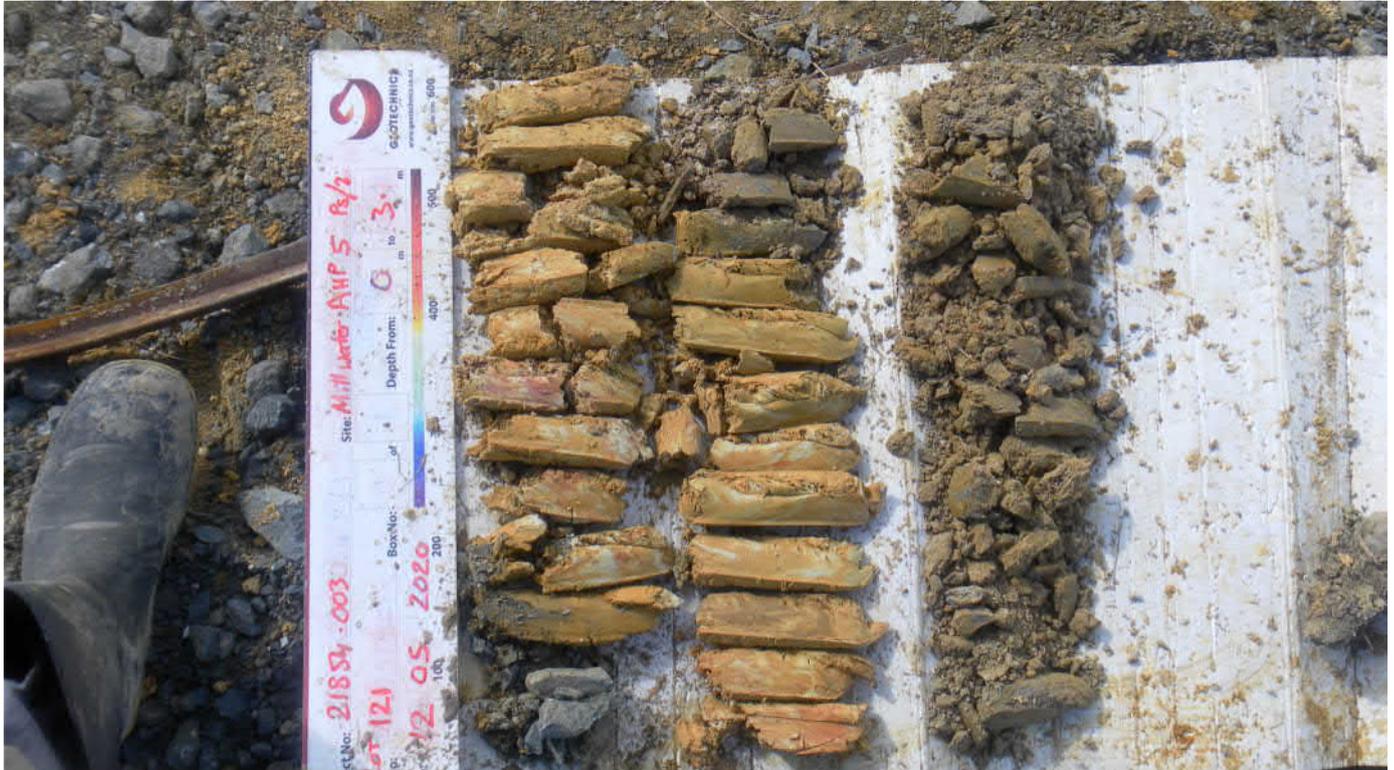
0.00-3.00m

PROJECT: Millwater P5 stg2		LOCATION: Orewa West	JOB No.: 21854.0031
CO-ORDINATES: (NZTM2000)	5949178.75 mN 1749214.40 mE	DRILL TYPE: 50mm hand auger	HOLE STARTED: 12/05/2020
R.L.:	24.10m	DRILL METHOD: HA	HOLE FINISHED: 12/05/2020
DATUM:	NZVD2016		DRILLED BY: GEOTECHNICS
			LOGGED BY: RBE CHECKED: WIRO

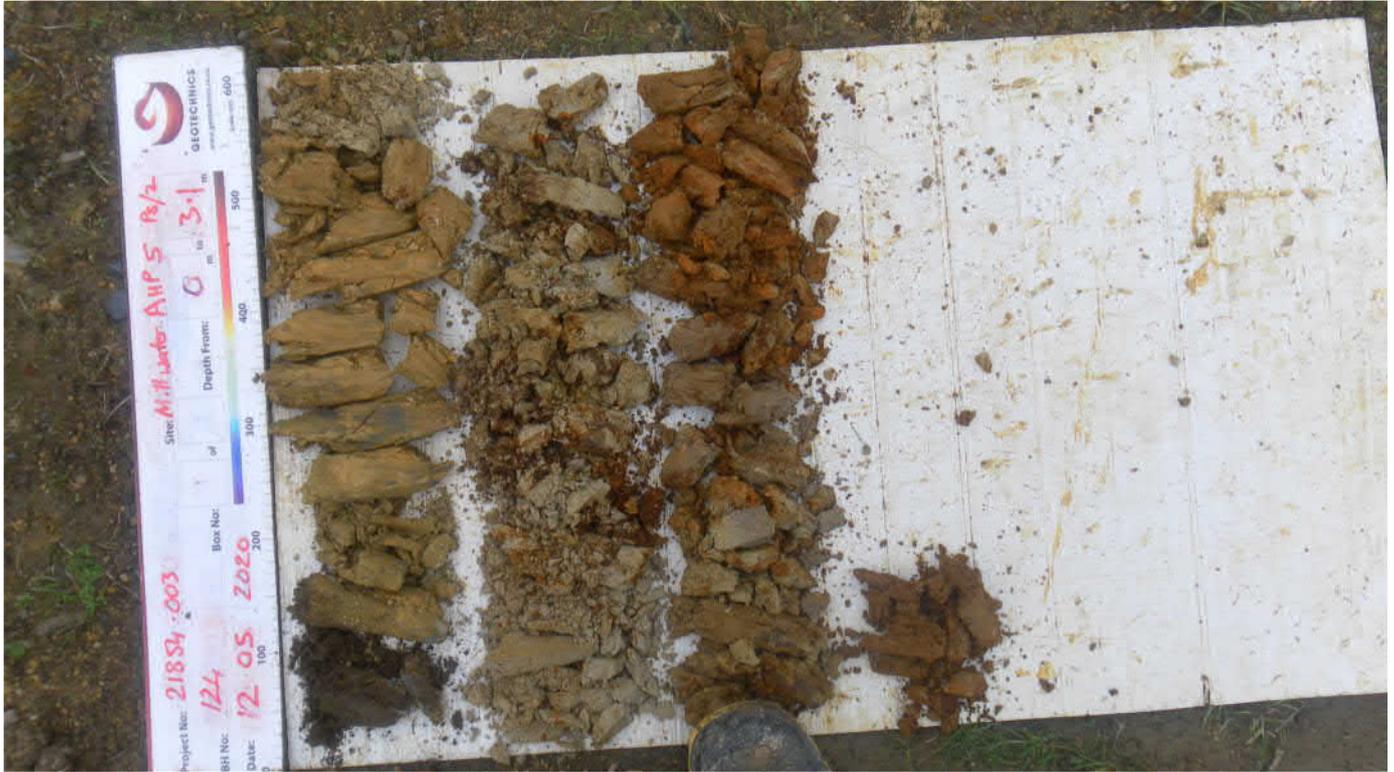
0.00-3.10m

PROJECT: Millwater P5 stg2		LOCATION: Orewa West	JOB No.: 21854.0031
CO-ORDINATES: (NZTM2000)	5949275.36 mN 1748955.00 mE	DRILL TYPE: 50mm hand auger	HOLE STARTED: 12/05/2020
R.L.:	30.30m	DRILL METHOD: HA	HOLE FINISHED: 12/05/2020
DATUM:	NZVD2016		DRILLED BY: GEOTECHNICS
			LOGGED BY: RBE CHECKED: WIRO

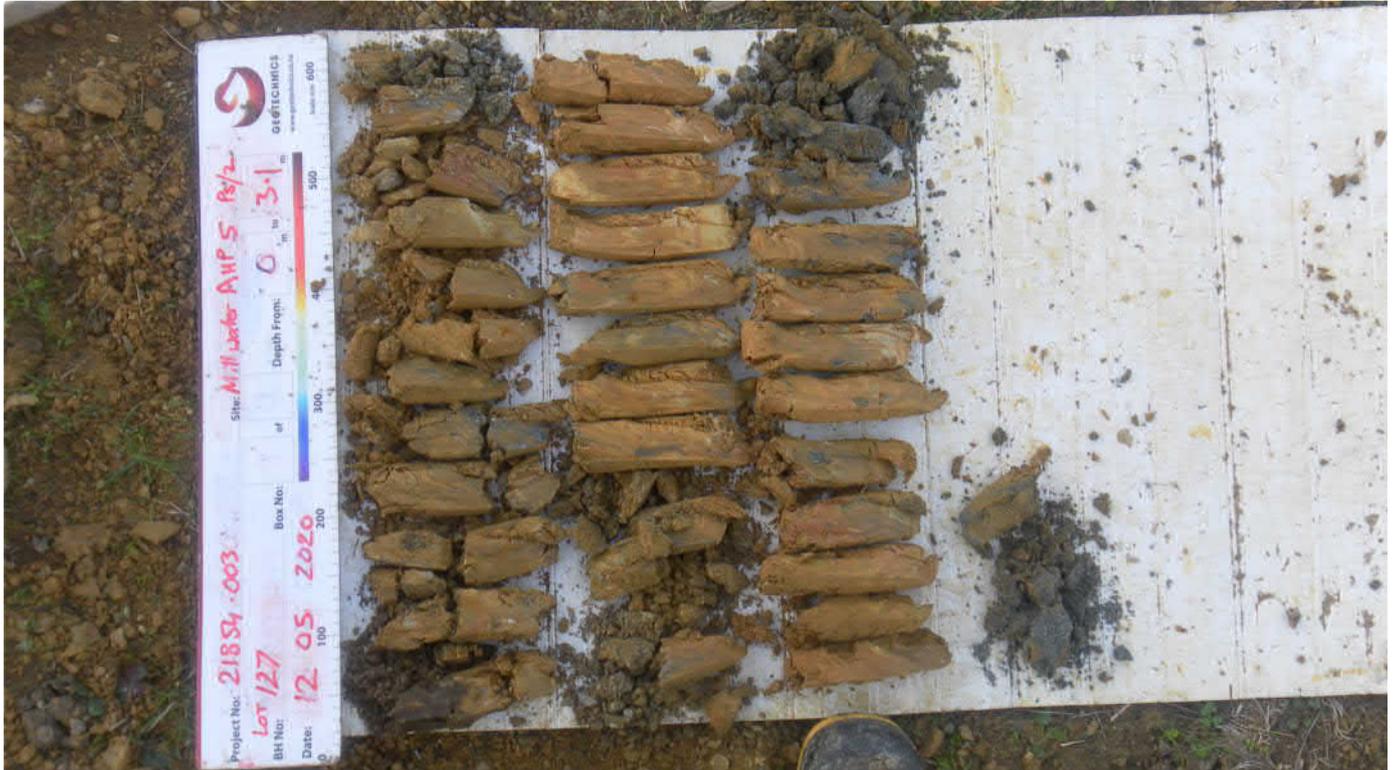
0.00-3.10m

PROJECT: Millwater P5 stg2		LOCATION: Orewa West	JOB No.: 21854.0031
CO-ORDINATES: (NZTM2000)	5949265.08 mN 1748998.64 mE	DRILL TYPE: 50mm hand auger	HOLE STARTED: 12/05/2020
R.L.:	32.90m	DRILL METHOD: HA	HOLE FINISHED: 12/05/2020
DATUM:	NZVD2016		DRILLED BY: GEOTECHNICS
			LOGGED BY: RBE CHECKED: WIRO

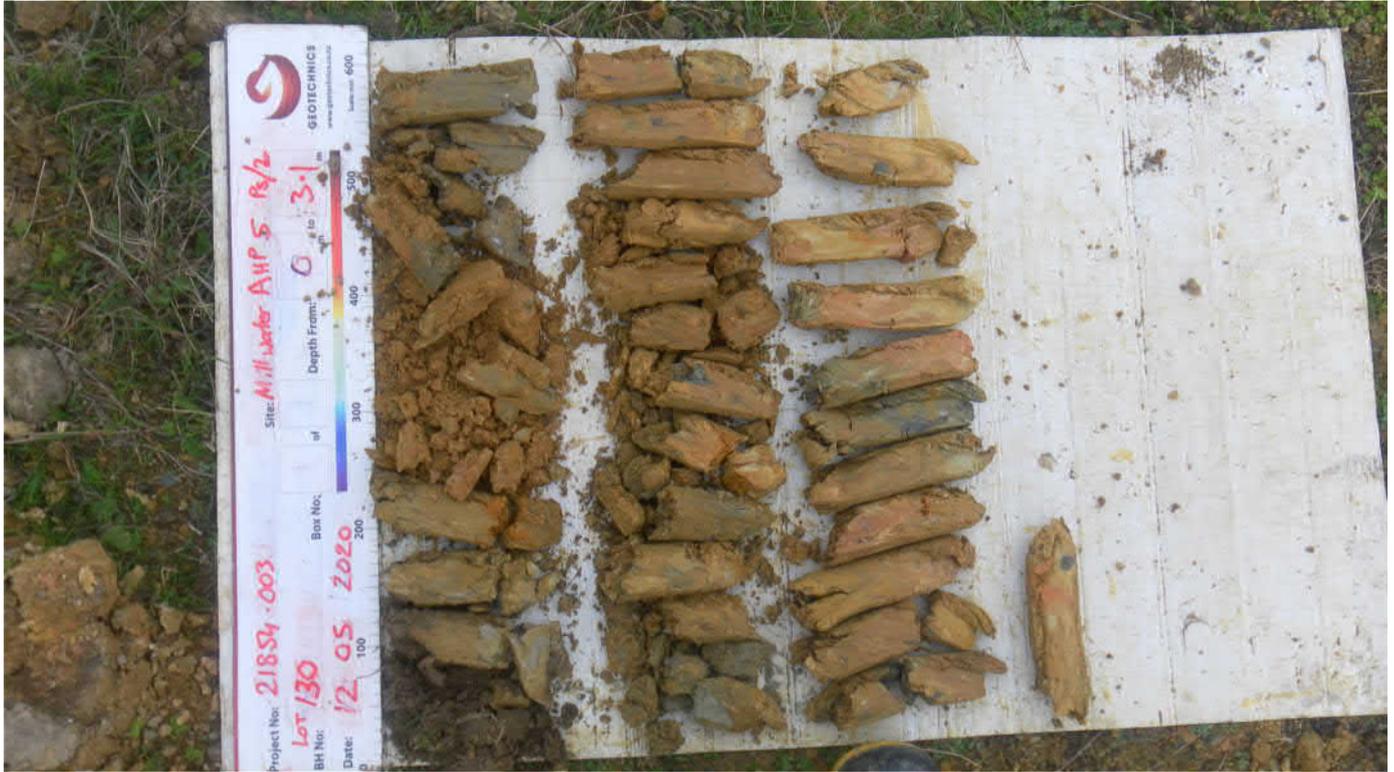
0.00-3.10m

PROJECT: Millwater P5 stg2		LOCATION: Orewa West	JOB No.: 21854.0031
CO-ORDINATES: (NZTM2000)	5949252.29 mN 1749045.01 mE	DRILL TYPE: 50mm hand auger	HOLE STARTED: 12/05/2020 HOLE FINISHED: 12/05/2020
R.L.:	33.00m	DRILL METHOD: HA	DRILLED BY: GEOTECHNICS
DATUM:	NZVD2016		LOGGED BY: RBE CHECKED: WIRO

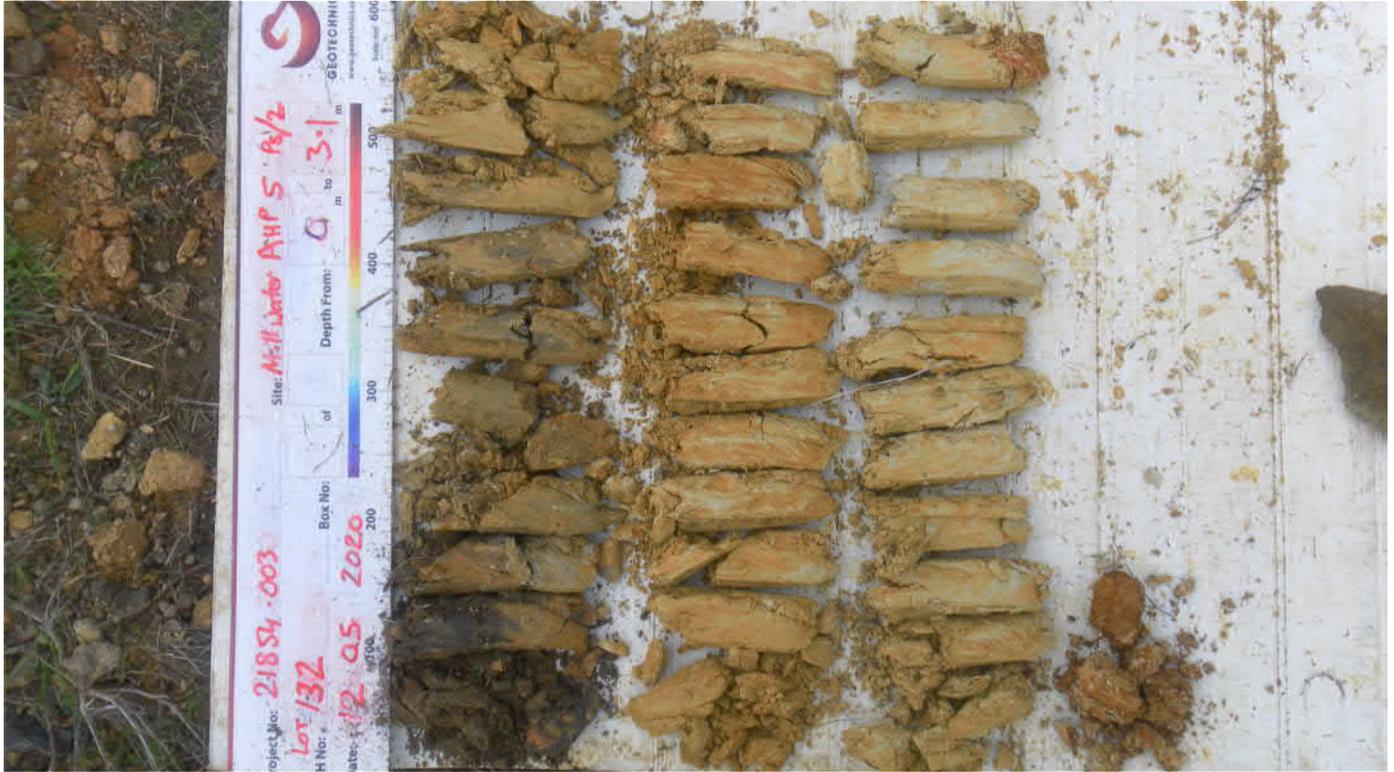
0.00-3.10m

PROJECT: Millwater P5 stg2		LOCATION: Orewa West	JOB No.: 21854.0031
CO-ORDINATES: (NZTM2000)	5949241.75 mN 1749091.35 mE	DRILL TYPE: 50mm hand auger	HOLE STARTED: 12/05/2020 HOLE FINISHED: 12/05/2020
R.L.:	32.98m	DRILL METHOD: HA	DRILLED BY: GEOTECHNICS
DATUM:	NZVD2016		LOGGED BY: RBE CHECKED: WIRO

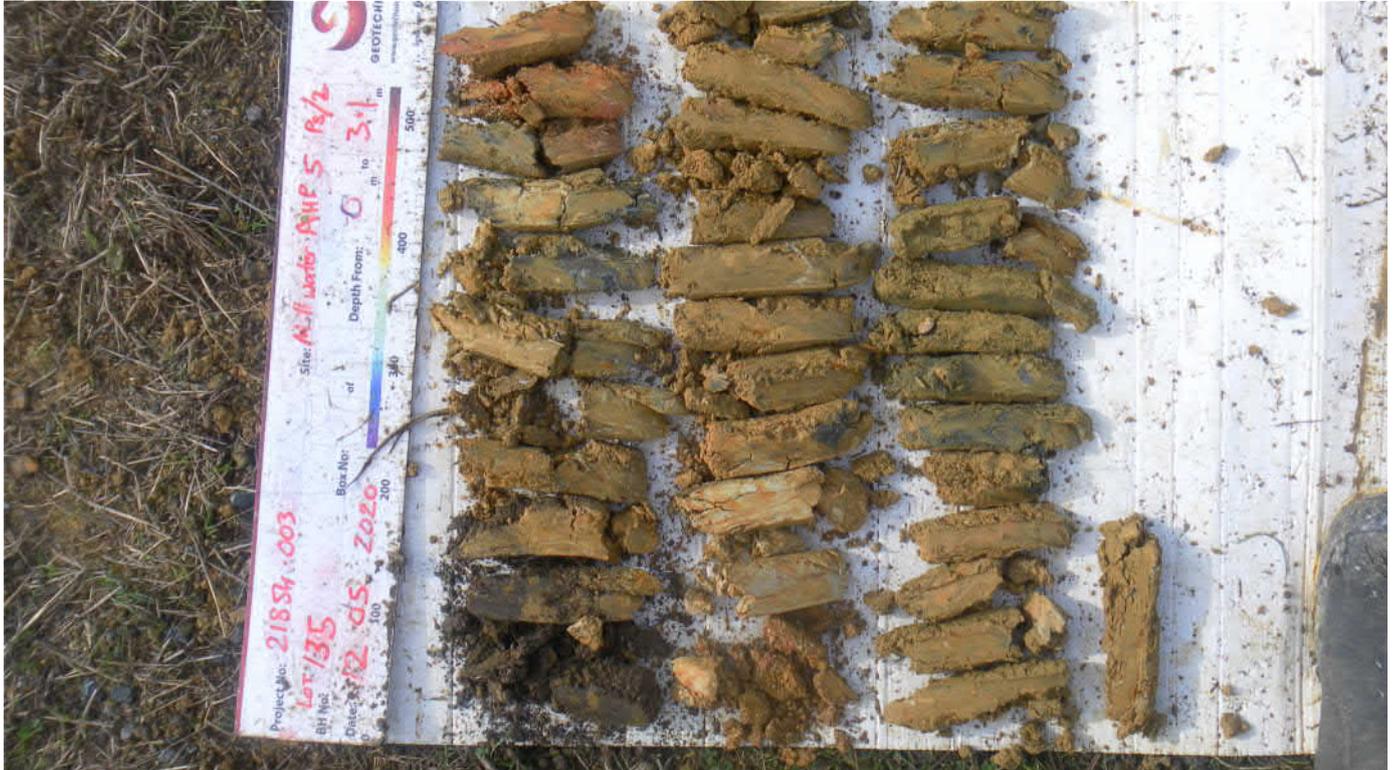
0.00-3.10m

PROJECT: Millwater P5 stg2		LOCATION: Orewa West	JOB No.: 21854.0031
CO-ORDINATES: (NZTM2000)	5949229.33 mN 1749135.63 mE	DRILL TYPE: 50mm hand auger	HOLE STARTED: 12/05/2020 HOLE FINISHED: 12/05/2020
R.L.:	32.21m	DRILL METHOD: HA	DRILLED BY: GEOTECHNICS
DATUM:	NZVD2016		LOGGED BY: RBE CHECKED: WIRO

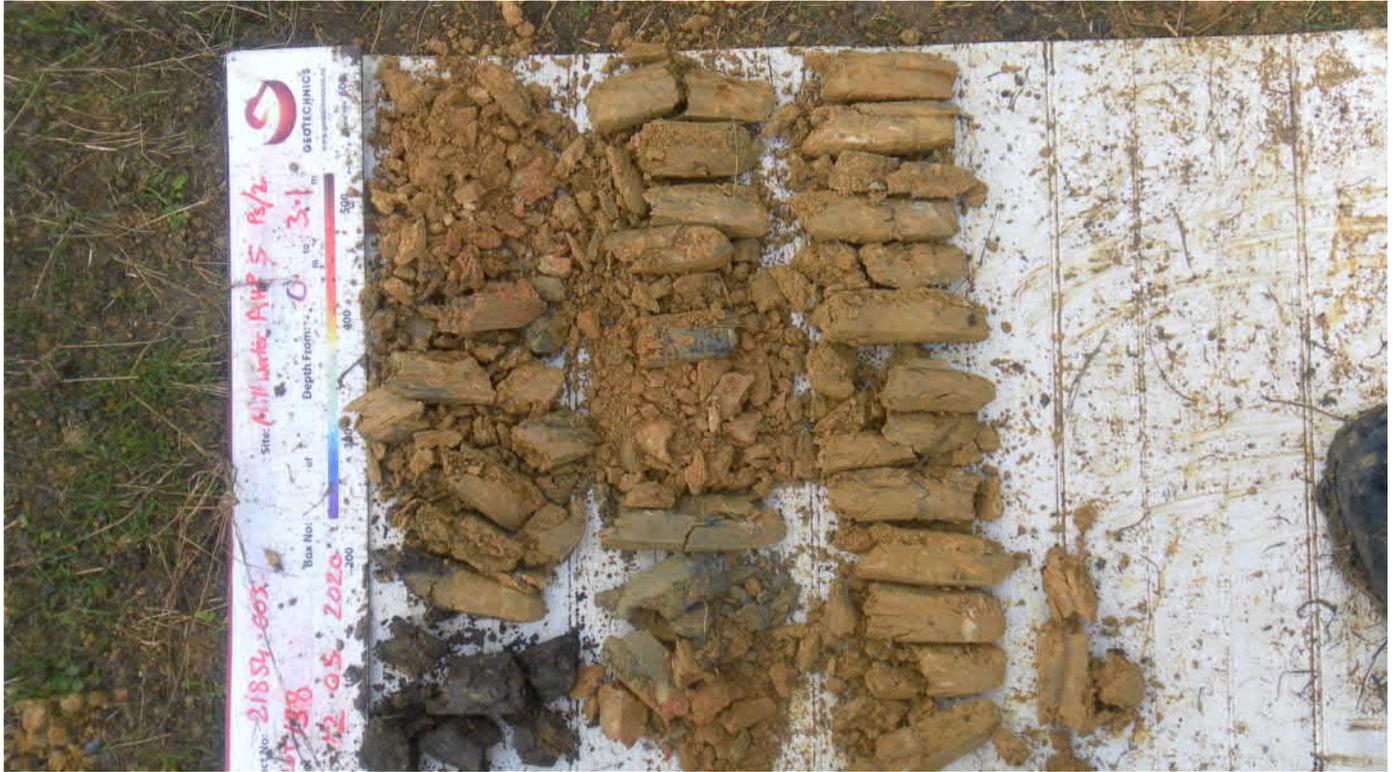
0.00-3.10m

PROJECT: Millwater P5 stg2		LOCATION: Orewa West	JOB No.: 21854.0031
CO-ORDINATES: (NZTM2000)	5949219.31 mN 1749181.28 mE	DRILL TYPE: 50mm hand auger	HOLE STARTED: 12/05/2020 HOLE FINISHED: 12/05/2020
R.L.:	29.59m	DRILL METHOD: HA	DRILLED BY: GEOTECHNICS
DATUM:	NZVD2016		LOGGED BY: RBE CHECKED: WIRO

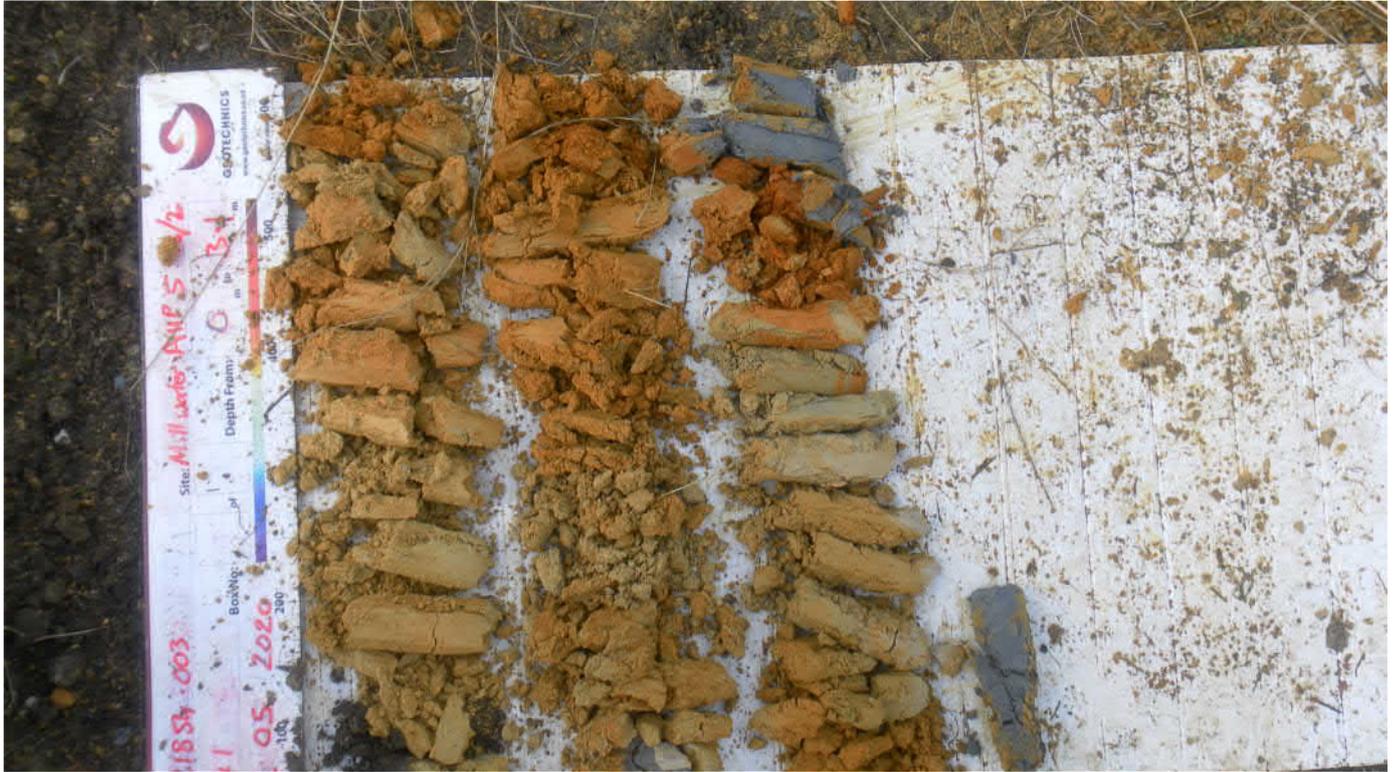
0.00-3.10m

PROJECT: Millwater P5 stg2		LOCATION: Orewa West	JOB No.: 21854.0031
CO-ORDINATES: (NZTM2000)	5949210.92 mN 1749224.03 mE	DRILL TYPE: 50mm hand auger	HOLE STARTED: 12/05/2020
R.L.:	25.36m	DRILL METHOD: HA	HOLE FINISHED: 12/05/2020
DATUM:	NZVD2016		DRILLED BY: GEOTECHNICS
			LOGGED BY: RBE CHECKED: WIRO
